# **New Home Inspections**

## **FRAME STAGE INSPECTION REPORT AND DEFECTS LIST**

**Address of Subject Property:**  
Lot 55 Sample Pde, Sampleville

**Date of Report – Thursday 4<sup>th</sup> March 2011**

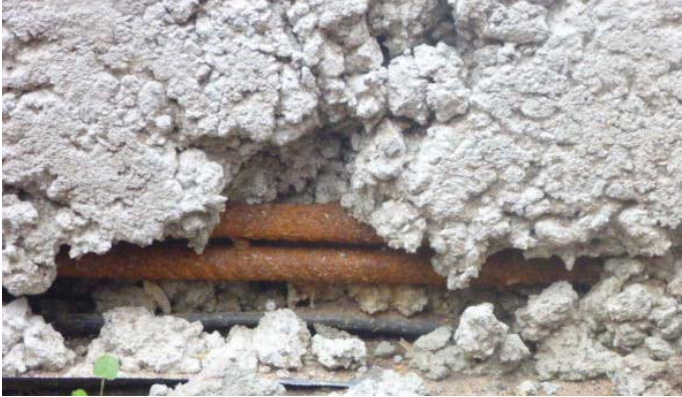
Item	Observations, Considerations and Recommendations:-
1.	<p>Concrete Floor Slab</p> <p>The steel reinforcement bars from within the floor slab have not been properly positioned prior to the concrete pour along the side wall of Bed 2 &amp; 4, the Rumpus room and the Master Bedroom and as a result have not been covered with concrete and remain exposed to the elements. These bars are starting to rust and will continue to do so over time, expanding as they do, which will lead to the possible future cracking of the slab as well as its possible long term failure.</p>

<p>It is a requirement of part 3.2.3.2 Steel Reinforcement, of the BCA's that <i>'Footings and slabs on ground must have concrete cover between the outer most edge of the reinforcement and the surface of the concrete of not less than 40mm to external exposure; Reinforcement must be cleaned of loose rust; and all reinforcement must be firmly fixed in place to prevent it moving during concreting operations.'</i></p> <p>The builder should remove the soil that has been pushed back up around the remaining edge beams and then have the original design engineers inspect and make recommendations on how to best treat this reinforcement and its lack of side coverage to ensure the slabs long-term performance. The owner/s should ensure that this rectification work is carried out under the full supervision of the relevant Building Surveyor.</p>

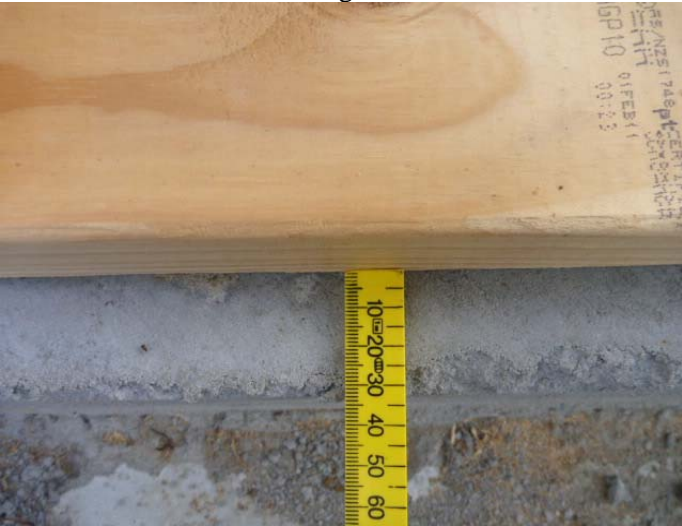
2.	<p>The edges of the floor slab have not been correctly boxed up prior to being poured, which has resulted in it protruding out past the pine wall frame along the side of the Family room by up to 32mm which will significantly reduce the required 40mm cavity width across to the back of the brickwork and compromise its ability to drain any water and moisture that collects in it away from the timber wall framing.</p>

<p>Part 3.3.4.2 Width of Cavity of the BCA, requires that <i>'In brick veneer construction, a cavity of not less than 25mm width must be provided between the inner and outer walls and the minimum cavity width is to be maintained between the outer masonry leaf and any services, insulation, sheet bracing or other element located within the cavity'</i>. Additionally, the relevant Australian Standard, A.S.3700-2001 Masonry Structures, clause 11.4.13 Cavities in Walls, requires that <i>'Cavities shall be free from mortar droppings or other materials that might bridge the cavity and allow transmission of moisture'</i>.</p> <p>The builder should therefore, after consultation with the slabs design engineer, carefully trim back the edges of the slab to achieve the required minimum 25mm cavity width, at least down to below the damp-proof course/cavity flashing. Consideration should be given to not</p>

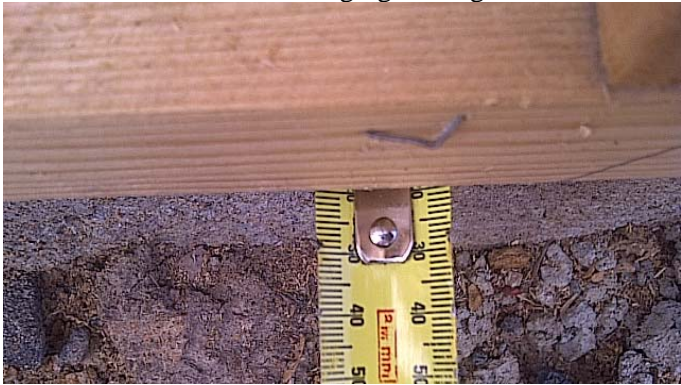
Item	Observations, Considerations and Recommendations:-
3.	<p>exposing the edge of the steel reinforcement or reducing its side cover; not reducing the throat of the edge beam; and also to any protrusion that may exist on the lower edge of the rebate out past the future finished face of the brickwork.</p> <p>The floor slab has been boxed and poured short along the side wall of the Kitchen, which has left the bottom plate of the wall frame overhanging the edge of the floor slab by up to 20mm.</p>

<p>The Building Commission's Guide to Standards and Tolerances clause 4.08 Bottom Plates that Overhang Concrete Slabs, states '<i>Bottom plates that are at least 90mm wide and overhang concrete slabs are defective. An overhang of up to 10mm is permissible</i>'. This overhanging bottom plate will need to be supported by an appropriately designed and certified engineered system so that it complies with this tolerance.</p>

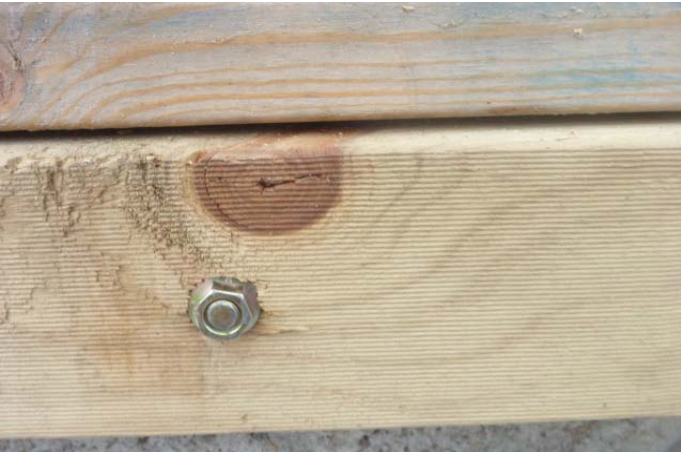
4.	<p>The bottom plate is also overhanging the edge of the floor slab along the side of the Bathroom and Bed 3 by up to 30mm, which has been supported on timber bolted to the edge of the slab in the horizontal position. The problem with this remedy is that as can be seen in the photograph below the timber support has already shrunk away, leaving the bottom plate unsupported and capable of rotating.</p>

<p>These present supports should be removed and replaced with either steel angle or timber cut to length down tight to the lower rebate in the horizontal plane.</p>

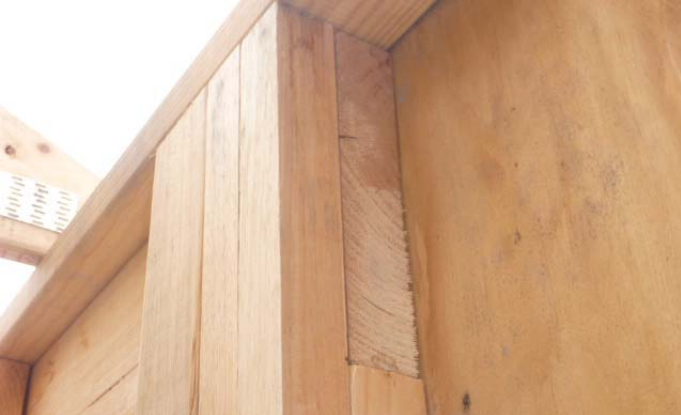
5.	<p>Framing Issues</p> <p>There have not been jamb studs installed to the ends of the lintels over most of the required window and doors openings throughout these Units.</p>

<p>It is a requirement of A.S 1684 Residential Timber-Framed Construction, clause 6.3.2.3 Jamb Studs (studs at sides of openings), that '<i>openings are to have 1 full-length stud on either side of the openings</i>'. Additional jamb studs will have to be installed to the required ends of these lintels.</p>

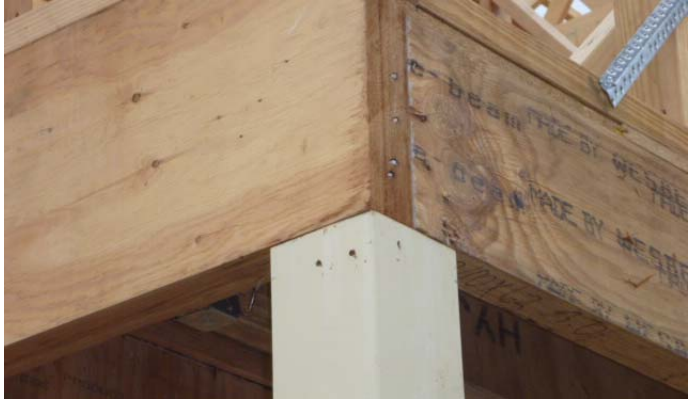
7.	<p>The roof beams over the Porch areas have not been tied or bolted to the post supporting them.</p>

<p>It is a requirement of Australian Standard, A.S 1684 Residential Timber-Framed Construction, clause 9.5 Nominal Fixings (Minimum Fixings), that <i>'Verandah beams and roof beams shall be joined to posts with 1/M12 or 2/M10 bolts'</i>.</p> <p>The fixing and tie-down detail of these beams to their post must be properly rectified in compliance with the above.</p>

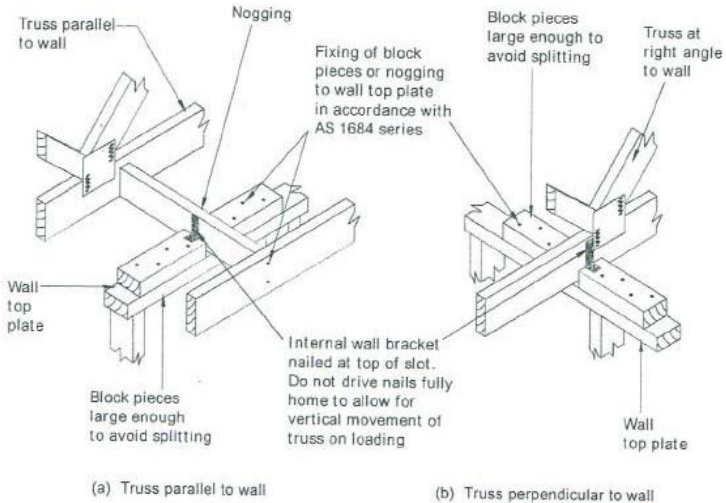
8.	<p>None of the internal braced walls have been fixed to the trusses with structural connections as required by clause 2.2.3 of A.S. 4440 Installation of Nailplated Timber Roof Trusses, the detail of which is shown below-</p>

<p>The fixing of the trusses to the required internal braced walls must be rectified in accordance with this requirement.</p>

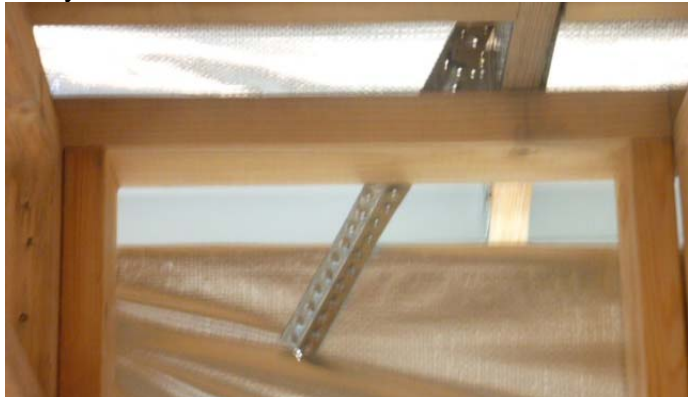
9.	<p>The diagonal speedbracing that runs across the tops of the trusses has not been fixed to the wall top plates correctly.</p>

<p>The manufacturer's installation guidelines state <i>'Bend the speedbrace to the side of the top plate and in under the plate. Fix with two nails to the side and three nails to under the plate. Nails must be no closer than 10mm to the edge of the timber. Shown below</i></p>

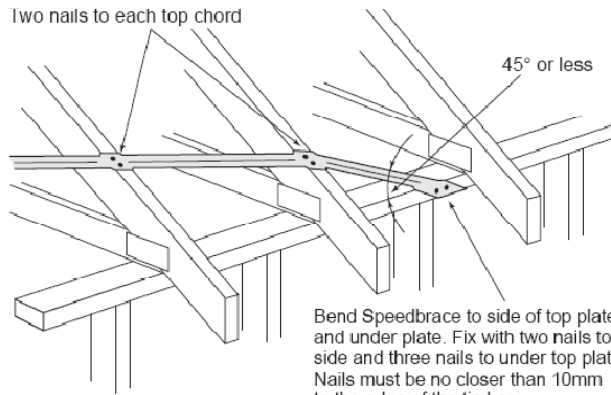
**Heel End Fixing Details**

Two nails to each top chord

The Speedbrace must be positively fixed to the top plate otherwise the bracing will be ineffective.

The fixing of the speed bracing must be rectified in accordance with the above, or if this method is not achievable then the alternative heel fixing detail must be used.

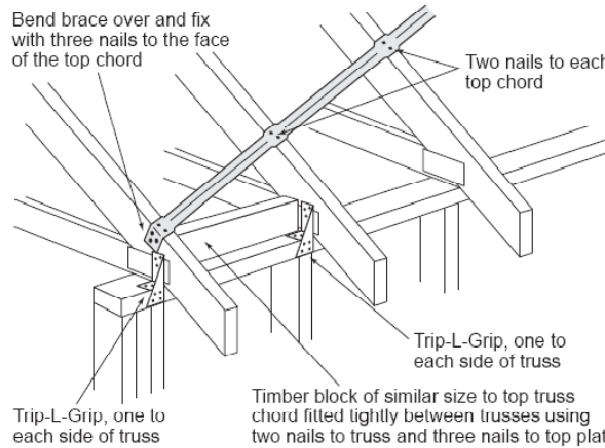
**Alternative Heel End Fixing Detail**

Bend brace over and fix with three nails to the face of the top chord

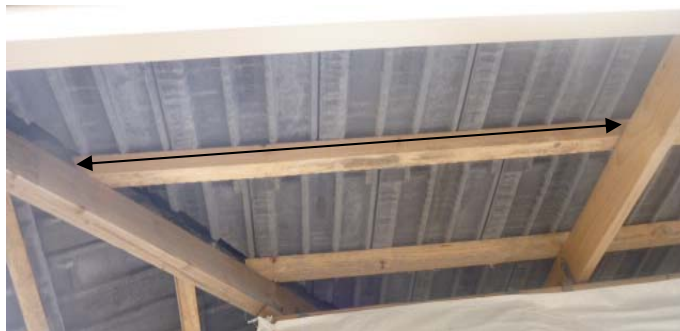
The bottom jack trusses are missing from each hip around the Porch and Lounge roof lines, which has left the roof tile battens spanning up to 1200mm, which would be more than their capabilities.

These jack trusses will have to be installed.
