MAINTENANCE STAGE INSPECTION REPORT AND DEFECTS LIST

Lot 5 No. 32 Sample Cct, Sample Heights

Date of Inspection – Tuesday 1st March 2011

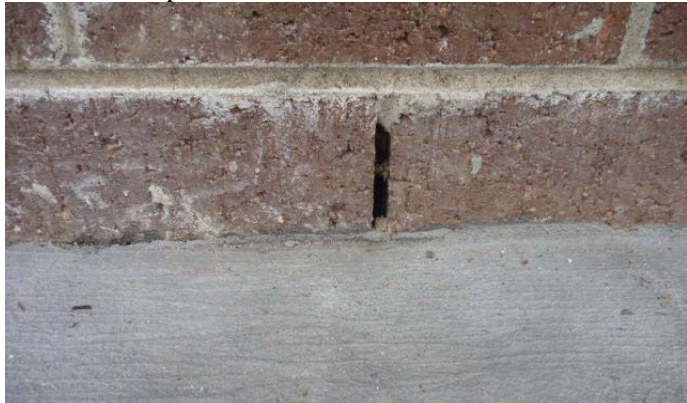
2.	Paving	<p>The paving that has been installed across the front wall of this home is over the front edge of the damp-proof course and weepholes.</p>

<p>It is a requirement of Part 3.3.4.5 Damp-proof course-installation of the BCA, that – <i>‘the height of a damp-proof course must be not less than 75mm above the finished surface level of adjacent paved, concreted or landscaped areas that slope away from the wall.’</i></p> <p>The placement of this paving must be rectified by the builder.</p>

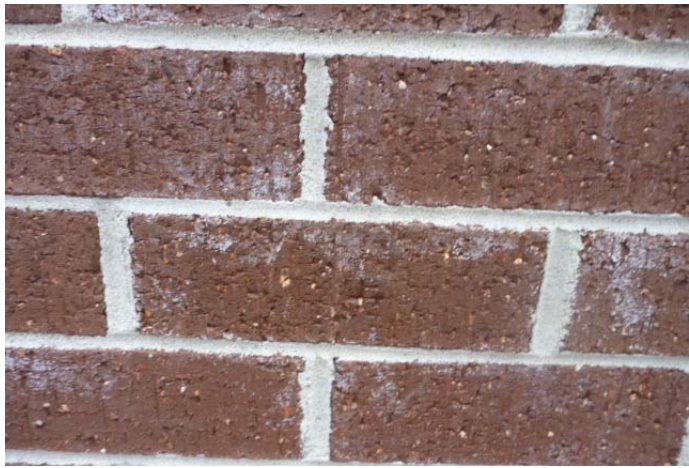
7.		<p>There are many areas around the walls of this house and garage that are displaying insoluble white deposits on the faces of the bricks.</p>

<p data-bbox="411 599 1517 730">There are a number of causes of this problem, the most common from when too much acid and not enough water is used in the initial clean, which causes the by-products of the reaction between the acid and the mortar to be absorbed into the brick faces instead of being washed clear of the wall.</p> <p data-bbox="411 743 1517 810">These walls will have to be re-cleaned with a product approved by the brick manufacturer to remove this staining.</p>
