# New Home Inspections

## PRE PLASTER INSPECTION REPORT AND DEFECTS LIST

**Address of Subject Property:**  
Lot 55 Sample Dr, Point Sample

**Date of Inspection – Tuesday 1<sup>st</sup> March 2011**

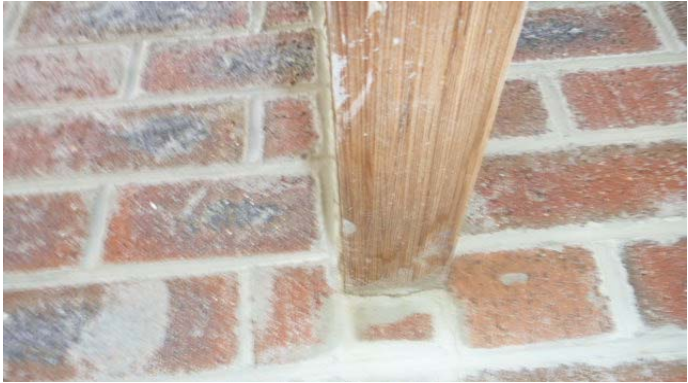
3.	<p>Brickwork</p> <p>The brickwork had been installed hard up to the underside of the roof beams around the Alfresco area.</p> <div style="text-align: center;">

</div> <p>Part 3.3.1.10 Shrinkage Allowance for Timber Framing of the BCA requires that <i>'In masonry veneer walls a gap must be left between the timber frame and the top of the masonry wall, including window sills ect, to allow for settlement of the timber framing caused by timber shrinkage. These clearances must be not less than 5mm at sills of lower and single storey windows; and 8mm at roof overhangs of single storey buildings'</i>.</p> <p>The brickwork below these beams will need to be lowered to achieve the required 8mm clearance.</p>

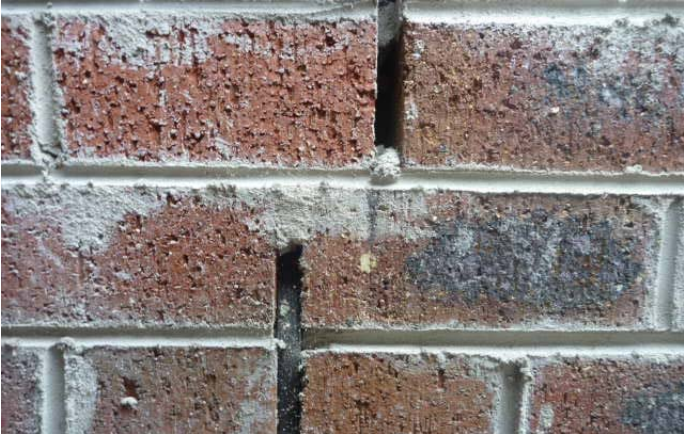
Item	Observations, Considerations and Recommendations:-
	<p><i>centres; and where openings more than 900 x 900mm occur, at not more than 5 metre centres.'</i></p> <p>I note the following deficiencies in the correct installation of the articulation joints around this home:-</p> <ol style="list-style-type: none"> <li>The articulation joint nominated on the approved plans to be installed between the side wall of the Master Bedroom and the Ensuite wall projection beside it has not been installed.</li> <li>The articulation joint nominated on the approved plans to be installed over the right hand side of the left hand Porch isolated pier up through the Balcony wall brickwork has not been installed.</li> <li>The articulation joint nominated on the approved plans to be installed beside the Kitchen window has not been installed.</li> <li>The articulation joint nominated on the approved plans to be installed to the left side of the front Games room window does not extend up through the brickwork over the window frame.</li> <li>The articulation joint installed beside the left side of Bed 3's window is breached and not continuous down the entire wall within the Rumpus room roof line.</li> </ol>

<p>These omitted or incorrectly installed articulation joints will stop the ability of the individual sections of these walls from being able to move independently to each other as they experience the expected footing movement and brick growth.</p> <p>The builder must therefore properly rectify/installed these articulation joints, with attention given to adequately tying the walls on each side of the joints back to the timber framework at maximum 300mm centres in accordance with the requirements of the relevant Australian Standards/BCA, which state-</p> <p>Australian Standard A.S. 3700 – 2001 requires in section 4.10 Wall Ties that <i>'Wall ties for cavity and masonry veneer walls shall be spaced no greater than 600mm in each direction. <u>Adjacent to lateral supports and control joints, and around openings in the masonry, with the first line of ties located within 300mm from the top of the wall, control joint or perimeter of opening</u>'</i>. Additionally, section 11.4.7 Building In requires that <i>'Wall ties and accessories embedded in masonry joints shall be built in as the construction proceeds'</i>.</p>

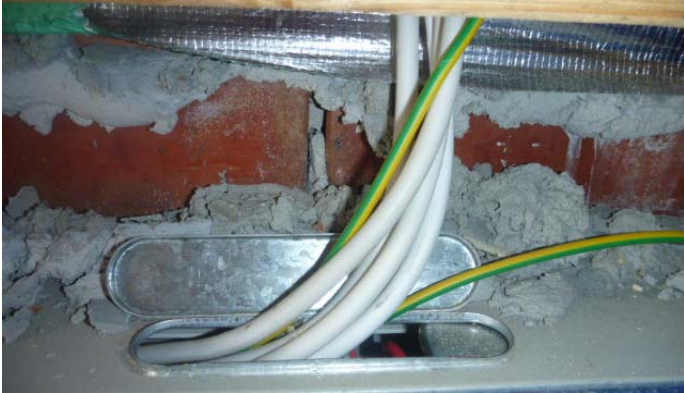
5.	<p>There has not been a cavity flashing installed inside the brickwork over the electrical meterbox.</p>

<p>Part 3.3.4.7 Location of Flashings of the BCA's requires a flashing must be provided where the cavity is interrupted by a structural element, <u>opening</u> or the like.</p> <p>This flashing must be properly installed to water-proof the top of the electrical meterbox and to stop the possibility of the ingress of any water into it.</p>

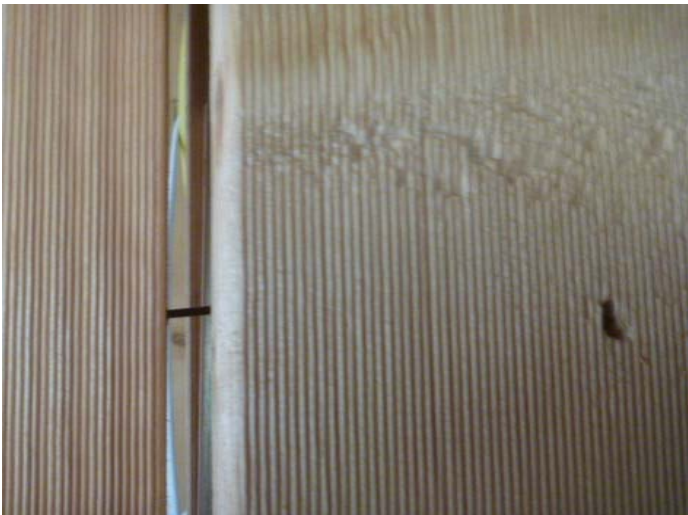
8.	Lock Up Issues	<p>The corner studs at the junction of each adjoining wall throughout this house have only been fixed with one nail into each of the corner block and these fixings are presently spaced at up to 1100mm centres. Additionally, not all of the corner studs have been pulled up tight to the blocks they are fixed into, which will lead to the future cracking down these internal plastered corners.</p>

<p>The relevant Australian Standard, A.S 1684.4 Residential Timber-Framed Construction - Simplified, clause 6.2.1.3 Wall Junctions states <i>'Internal and external walls shall be fixed together with a minimum of 2/75mm nails at 800mm maximum centres'</i>.</p> <p>All of these corner studs need to be pulled up tight to each other and have additional nails fixed through them to within the 800mm maximum spacing, to stop the future cracking of the internal plastered corners.</p>

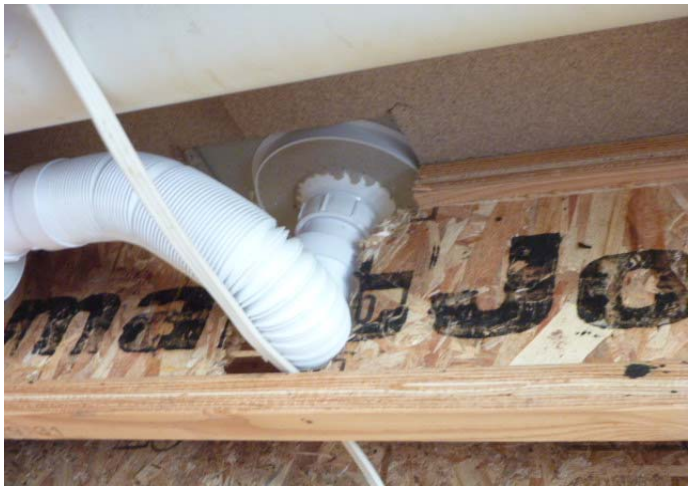
11.		<p>The top flange of the SmartJoists over the Meals area has been cut through for the installation of the shower waste.</p>

<p>The SmartJoists installation instructions clearly warns:-</p>

<p data-bbox="651 385 1297 472" style="text-align: center;"><b>DO NOT CUT OR NOTCH FLANGES DO NOT OVER CUT HOLES IN WEB</b></p> <p data-bbox="416 491 1520 553">This SmartJoist will have to be properly rectified under the instruction of their manufacturer who should supply the detail for the required rectification work.</p>

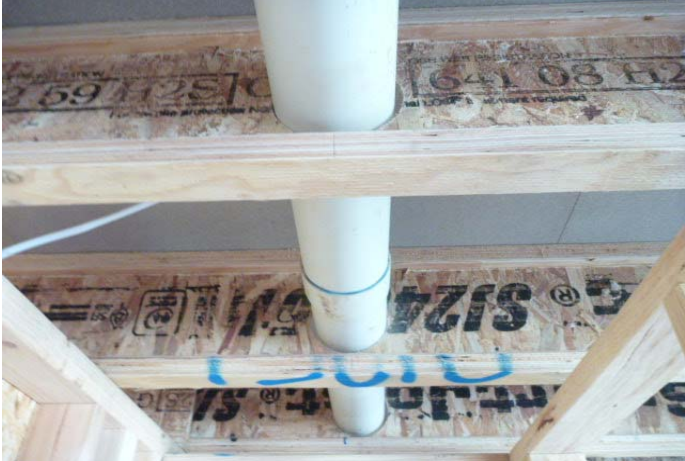
12.	<p data-bbox="416 560 1520 691">There have been 240 x 51 SmartJoists installed as the first floor joists across the Kitchen area of this home. There have been circular holes with a diameter of up to 115mm drilled through the webs of the joists over the Pantry area that are approximately 300mm out from the internal load-bearing wall.</p>

<p data-bbox="416 1157 1520 1317">The manufacturer's Hole Chart states that the <u>minimum</u> distance out from a supporting wall that holes of this size can be drilled through the webbing of joists over this span is 1300mm. The manufacturer notes in this chart state that these spacings are conservative and that the most accurate method for the design of web penetration sizes and distances is by their software.</p> <p data-bbox="416 1338 1520 1464">As the present spacings of these sized holes breach the manufacturers Hole Chart the builder should confirm the acceptability with the manufacturer and either rectify these joists as directed or supply the manufacturers certification of the present as built situation back to the owner.</p>

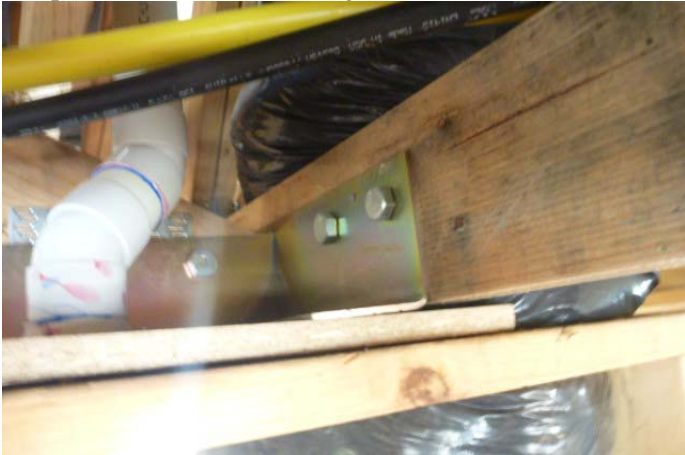
13.	<p data-bbox="416 1478 1520 1540">The chipboard lid that has been installed across the top of the Return Air duct to seal it to the flexible duct is hard up to the underside of the girder truss over it.</p>

<p data-bbox="416 1995 1520 2057">This practice will now stop the trusses from being able to deflect as it was designed too; as well as now making the internal non load-bearing walls load-bearing.</p> <p data-bbox="416 2077 1520 2107">This chipboard must be removed and the top of the duct sealed in some other manner.</p>

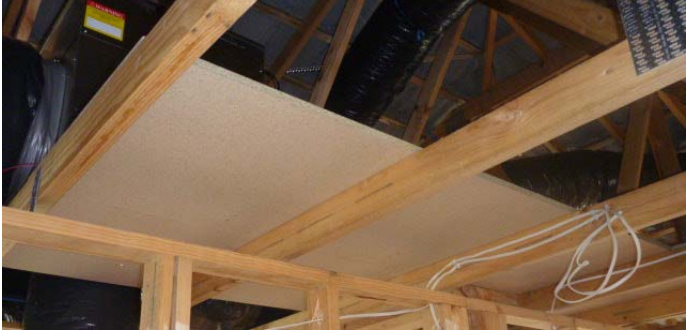
14.	<p data-bbox="416 2114 1520 2206">The chipboard flooring to support the heating unit has been fixed directly down onto the tops of the truss bottom chords without the required bearer to spread the load of the heating unit across the trusses supporting it.</p>

<p data-bbox="413 466 1520 530">Truss manufacturers require that <i>'Platforms to support heating units must be located across ALL three trusses to spread the units load evenly across them by way of bearers.'</i></p>

<p data-bbox="799 764 1161 904"><b>Bearers to be directly under heating unit, and as close to panel points as possible.</b></p> <p data-bbox="413 918 1520 982">The present chipboard will need to be lifted up onto bearers to properly spread the load across the required trusses as required by the truss manufacturer.</p>

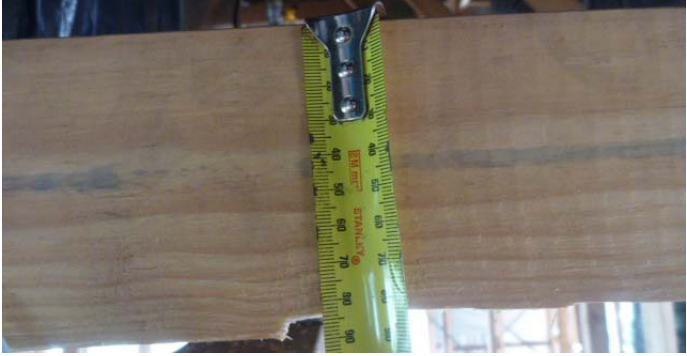
15.	<p data-bbox="413 989 1520 1053">There are two trusses across the Bed 3/TV area wall that have had their 90mm bottom chords reduced back to only 83mm to straighten the ceiling lines.</p>

<p data-bbox="413 1407 1520 1469">The adequacy of these trusses needs to be confirmed by their manufacturer or otherwise rectified under their instruction.</p>
