New Home Inspections

FRAME STAGE INSPECTION REPORT AND DEFECTS LIST

Address of Subject Property:
55 Sample Pde, Sampleville

Date of Inspection – Friday 13th March 2009

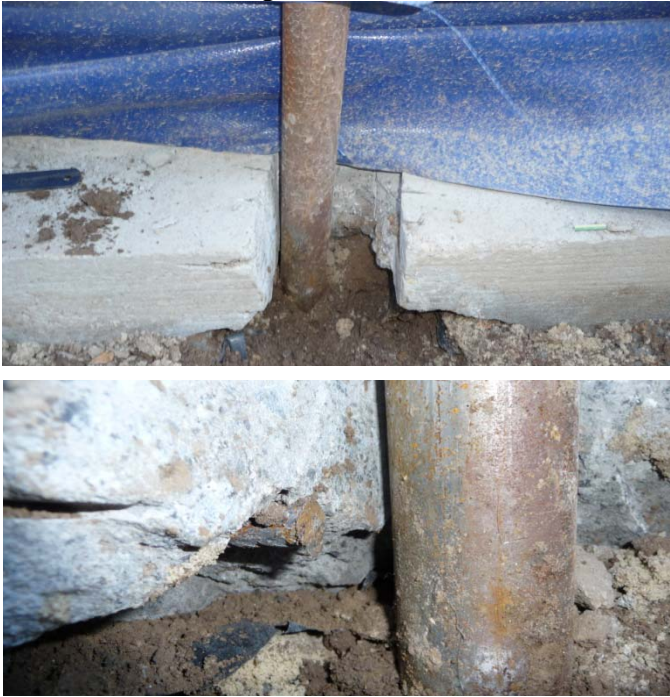
Defective Item	Observations, Considerations and Recommendations:-
Compromised Slab	<p>The edge beam of the concrete slab and the steel reinforcement within it along the side of the Master Bedroom has been cut through for the installation of the electrical service pipe.</p>

<p>This cut through edge beam and steel reinforcement must be inspected by the original design engineer, who should make recommendations on how best to rectify the compromised integrity of this slab and also on how best to treat the exposed steel reinforcement to stop it from rusting.</p> <p>The owners should ensure that the rectification works are carried out under the full supervision of the relevant Building Surveyor.</p>
Termite Protection	<p>The perimeter termite barrier that has been installed in under the timber bottom plate has been torn across the front and down the left hand side of the Master Bedroom; as well as under the Family room sliding doorframe; has not been detailed around the above mentioned electrical service pipe, which will now require it to be cut; the wall braces across the rear walls appears to be too long and will penetrate this barrier when it is turned up across the cavity; and has not been installed at all around the timber nib wall between the front Porch and the Garage.</p>

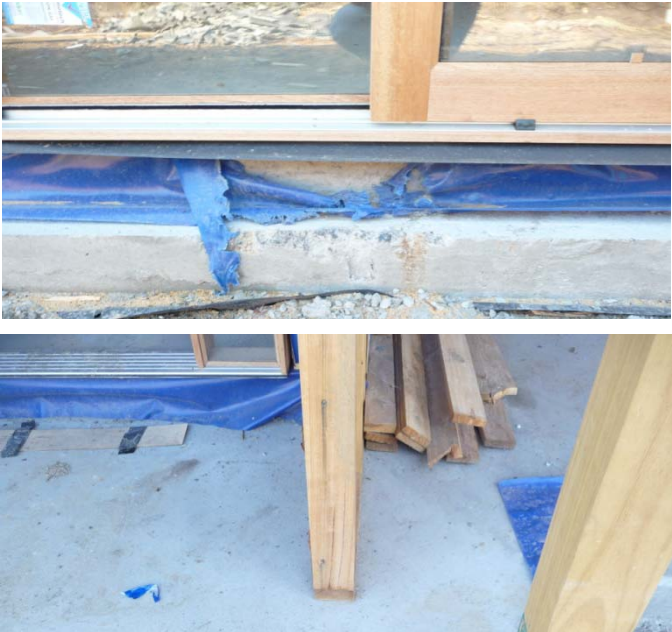
Defective Item	Observations, Considerations and Recommendations:-
Termite Protection (cont.)

<p>The present installation of this termite barrier must be properly repaired, detailed and installed as required and wall braces trimmed back so that they do not penetrate it. Attention should also be given to the future connection of the bath wastes.</p>

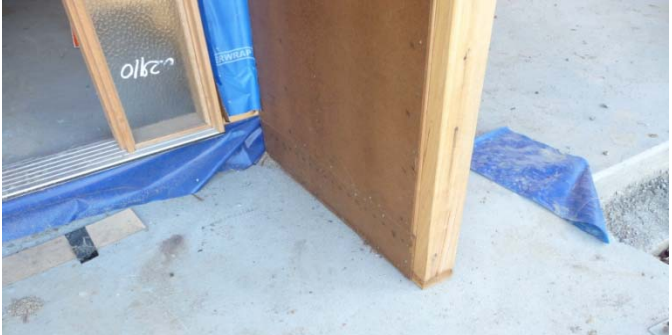
Concrete Slab Rebate/ Damp-proof Course	<p>The builder has not installed a step down between the Garage floor and front Porch slab heights, nor have they constructed the front Porch with any fall on it to move any surface water away from this area.</p>

<p>The problem with the current construction detail is that the load-bearing wall plate between these areas is only plain ordinary <u>untreated radiata pine</u>, which has little or no resistance to timber rot.</p> <p>The present construction will leave the damp-proof course/cavity flashing at the same height as the Porch floor, which will allow water and moisture to migrate in under the brickwork and into the pine bottom plates, which will cause it to rot out and fail.</p> <p>Part 3.2.2.7 Edge Rebates of the BCA, requires that <i>'an edge rebate for waffle raft slabs with masonry cavity or veneer construction must not be less than 20mm; and that the edge rebate must be flashed and drained in accordance with Part 3.3.4.'</i></p> <p>Part 3.3.4.5 Damp-proof courses-installation of the BCA requires that <i>'damp-proof courses must be located in accordance with Figure 3.3.4.1 to form a continuous damp-proofing barrier around the building.'</i></p>
