New Home Inspections

PRE HANDOVER INSPECTION REPORT AND DEFECTS LIST

Address of Subject Property:
55 Sample Pde, Sampleville

Date of Inspection – Monday 16th March 2009

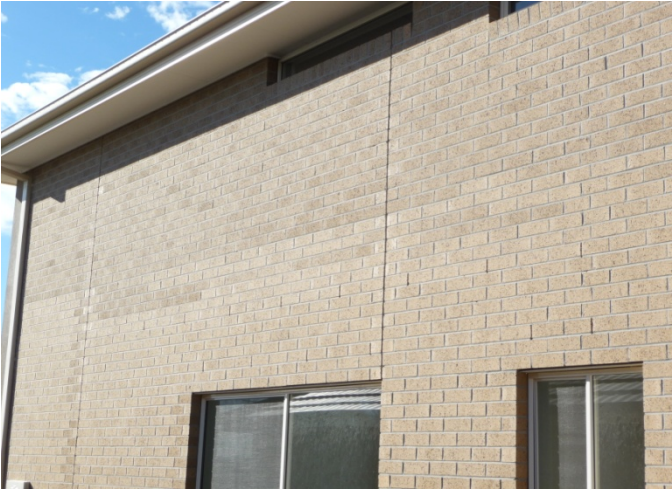
Defective Item	Observations, Considerations and Recommendations:-
Brickwork	<p>The top 20 or so courses along the side walls of this house are of a darker colour to the rest of the walls and have not been blended properly as can be seen in the following photograph:-</p>

<p>The Building Commissions, Guide to Standards and Tolerances clause 3.06 Blending and Matching of Masonry – New Work’ states that <i>‘Masonry areas that vary in colour are defective if the units are not mixed and/or distributed in accordance with the manufacturer’s installation instructions’</i>.</p> <p>Blending refers to the process of mixing the bricks or pavers to evenly distribute the product colours across the entire finished wall or pavement. This is an important step whether the products you have delivered are a single colour or are multi-coloured. Blending instructions are supplied on the sides of brick packs when delivered and recommend:-</p> <ol style="list-style-type: none"> 1. Work from at least three open packs at any one time; and 2. Select the top bricks from the left of each pack; and 3. Work progressively from a corner across and down each pack in a diagonal pattern. Do not unpack the bricks in horizontal layers. <p>Clearly the blending of the bricks along this side wall has not been carried out correctly and now will have to have to be rectified.</p>

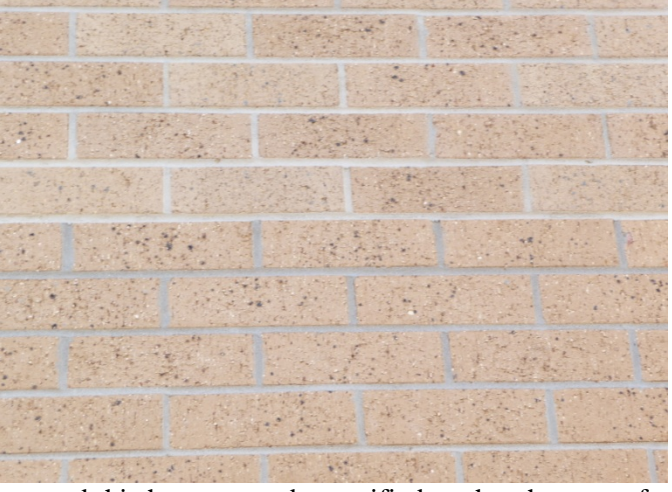
<p>The mortar joints change in colour in the upper walls at approximately the same point as detailed above.</p>

<p>The mortar joints around this house must be rectified so that they are of a similar coloured finish.</p>
	<p>The brickwork along the side wall of the Garage overhangs the edge of the slab by up to 25mm.</p> <p>Part 3.2.2.7(b) Edge Rebates of the BCA’s states that; ‘Exterior masonry must not overhang more that 15mm past the edge of the slab’.</p> <p>Thus section of brickwork will need to be extended using an appropriately designed and certified engineered system.</p>

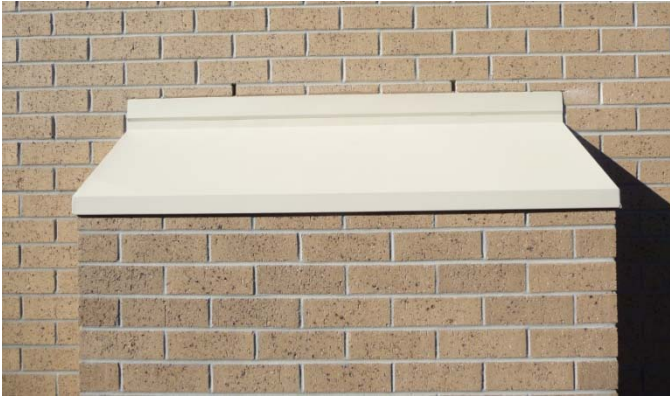
Defective Item	Observations, Considerations and Recommendations:-
Brickwork (cont.)	<p>The overflashing to the Family room firebox projection covers the bottom of the opening cavity flashing weepholes, which will allow them to drain in behind them and onto the top of the metal firebox.</p>

<p>This Overflashing must be lowered down below these weepholes or the cavity flashing raised up a course.</p>
	<p>There has not been a damp-proof course/cavity flashing, or the accompanying weepholes, installed around the bases of the firebox projection in the Family room.</p> <p>Part 3.3.4.5 Damp-proof courses-installation of the BCA requires that '<i>damp-proof courses must be located in accordance with Figure 3.3.4.1 to form a continuous damp-proofing barrier around the building</i>' (see below).</p>

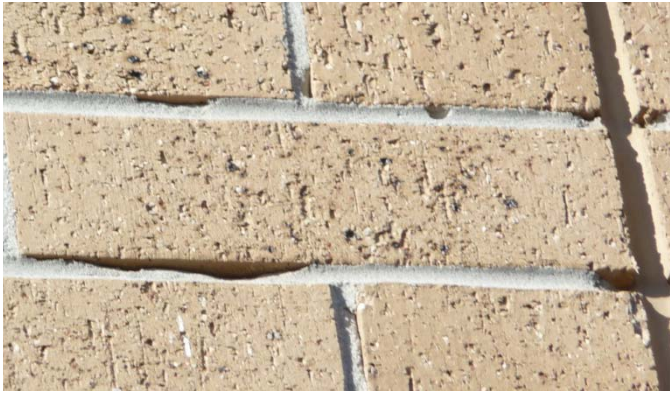
<p>There are numerous voids and holes in the finished faces of the mortar joints around this house and garage.</p>

<p>The Building Commission's Guide to Standards and Tolerances clause 3.09 Voids and Holes in Mortar, states that- '<i>Voids and holes in mortar in masonry walls, excepting weepholes and vents, are defects if they are visible from a normal viewing position</i>'.</p> <p>These voids and holes should be properly patched prior to the affected areas of the walls around this house and garage being re-cleaned.</p>
	<p>The brickwork along the side of the garage still needs to be properly cleaned down where some bricks have been replaced, as there is still mortar across the face of the bricks.</p> <p>The Building Commission's Guide to Standards and Tolerances clause 3.07, Masonry Facing states that:- '<i>Masonry faces are defective if they are not cleaned and free of excess mortar</i>'.</p> <p>All of the affected walls around this house and garage will have to be re-cleaned.</p>

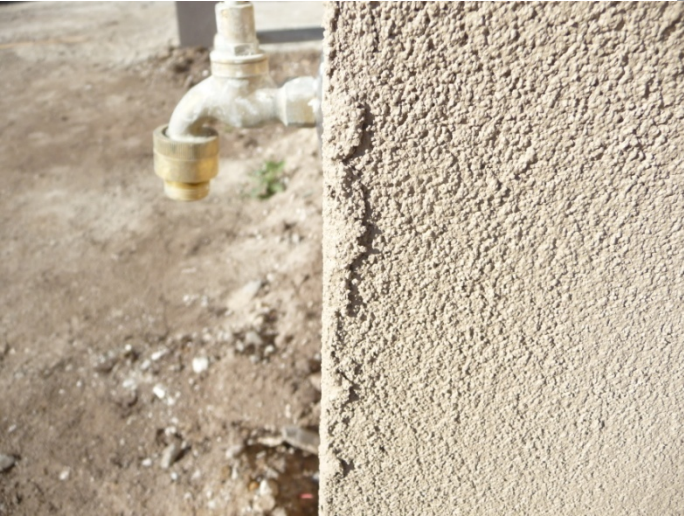
<p>The weepholes within the rendered front walls of this home are partially filled with render and vary in their size, height and width.</p> <p>Part 3.3.4.3 Cavity Ventilation and Drainage, of the BCA’s requires that <i>‘Open perpendicular joints (weepholes) must be created in the course immediately above any damp-proof course or flashing’</i>.</p> <p>These weepholes will need to be properly cleaned out with extreme care not to damage the damp-proof/cavity flashing that is located below them and made to be consistent in size.</p>
	<p>The render has not been finished of smoothly across its face into most of the external corners and as a result the faces of the walls have excessive render build up on them.</p>

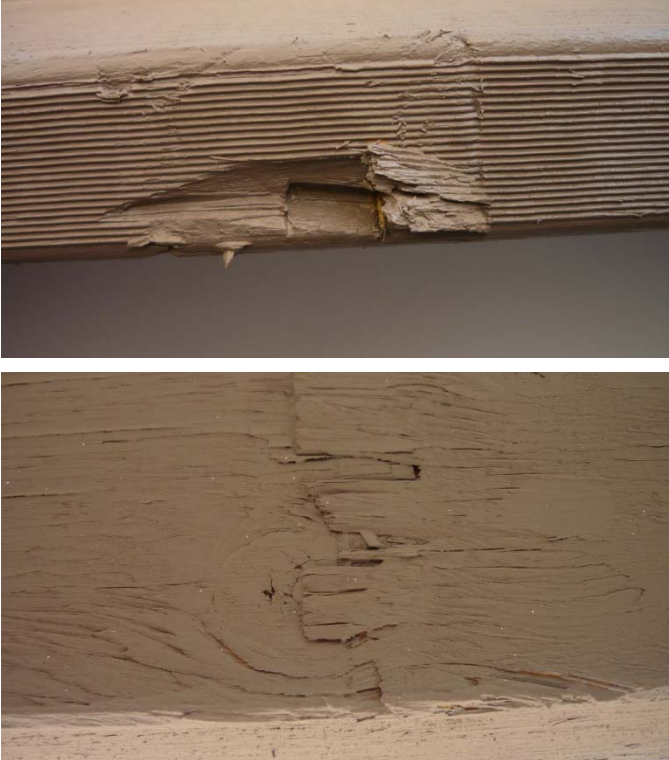
<p data-bbox="405 548 1497 610">The faces of all of the front wall areas will need to have the render finished off across it to a smooth, consistent and flat finish.</p>
Alfresco Roof Beams	<p data-bbox="405 619 1497 681">The bottom edges and faces of the roof beams around these areas contain many chips and splits along them.</p>

<p data-bbox="405 1446 1497 1643">The Building Commission's Guide to Standards and Tolerances clause 12.04 states '<i>Holes and any other unfilled depressions in paint or stained timber such as surface defects caused by mechanical damage, natural characteristics such as gum pockets or surface splits are defects if they can be seen from a normal viewing position</i>'. A normal viewing position in this situation would be at a distance of 1.5 metres or greater back from these beams.</p> <p data-bbox="405 1662 1497 1724">All of the faces and edges of these beams need to be properly filled and sanded back prior to being repainted.</p>

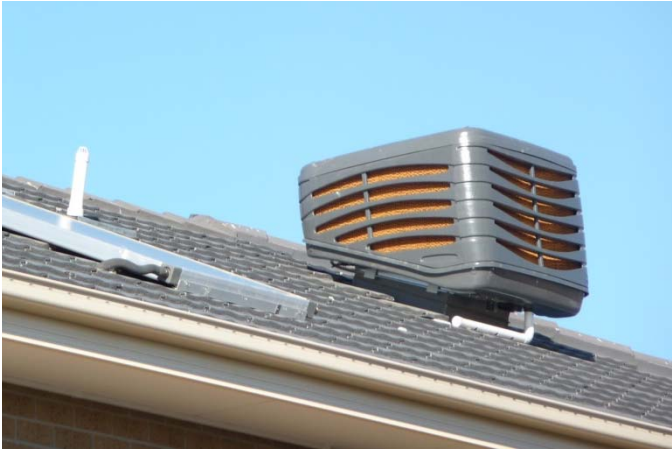
Evaporative Cooker/ Sewerage Vent	<p>The vent from the sewer drains is located approximately 2 metres from the Evaporative Coolers intake vents.</p>

<p>Section 4.33.7 Termination of A.S/NZS 3500.5:2000 National Plumbing and Drainage Part 5: Domestic Installation requires that – <i>‘Vents shall terminate in the open air and in a location not less than 5 metres in any direction from any air duct intake’</i>.</p> <p>The location of these items to each other must be separated in accordance with the above to stop the stale sewerage air being drawn back into the Evaporative Cooler intake vents and distributed throughout this house via its ducting outlets.</p>
Windows	The rubbers on the window frames across the rear upper walls need to be trimmed to length as required.
Garage	The rebated edges of the floor slab need to be filled into the rear faces of the side brick work.
	The floor slab needs to be properly cleaned down to remove the present mortar and plaster compound from across it and the holes across the top of it need to be properly filled and blended in.
