New Home Inspections

PRE PLASTER INSPECTION REPORT AND DEFECTS LIST

Address of Subject Property:
55 Sample Pde, Sampleville

Date of Inspection – Monday 16th March 2009

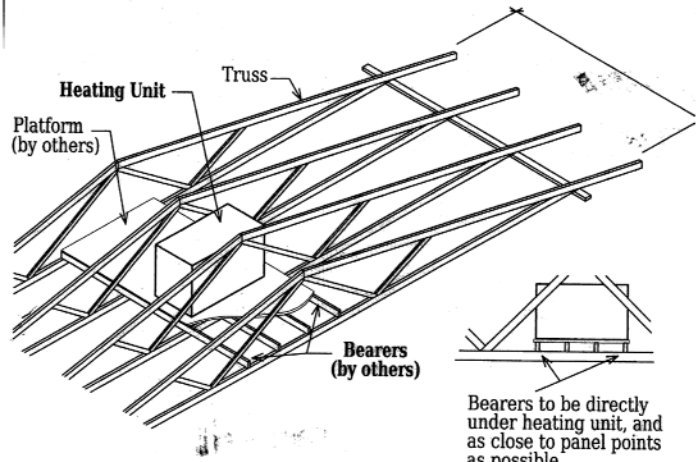
Defective Item	Observations, Considerations and Recommendations:-
Timber External Doorframes	<p>The timber doorframes to the Front Entry and Alfresco bifold doors have not had sill flashing installed onto them in accordance with the requirements of Part 3.5.3.6 Flashings to Wall Openings of the BCA, which will allow water to penetrate in under them into the finished floor coverings.</p> <p>These frames will now have to be removed and the sills properly flashed before they are re-installed with attention paid to the flashing being turned down into the cavity.</p>
Heating Unit Platform	<p>The heating unit's chipboard platform has been fixed directly onto the tops of the trusses bottom chords, which is not in accordance with their manufacturer's installation instructions.</p> <p>As shown below, the manufacturer requires bearers to span across a minimum of 4 trusses before the chipboard platform is fixed down onto them.</p> <div style="text-align: center;"> <h3>Heating Unit Details</h3> <p>Heating unit platform to span over 4 trusses via bearers, as shown. See truss layout for location.</p>

<p>Bearers to be directly under heating unit, and as close to panel points as possible.</p> </div> <p>The installation of this platform will have to be rectified in accordance with the manufacturer's requirements.</p>

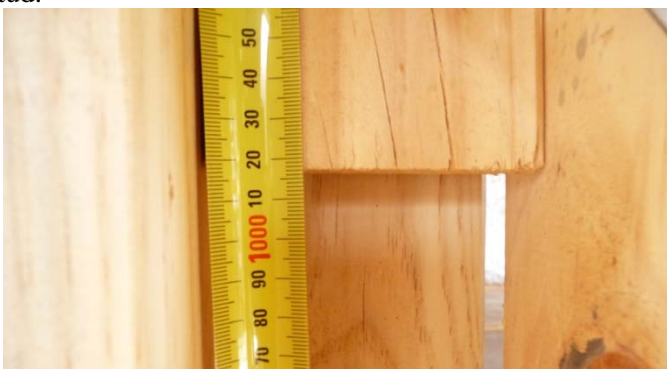
Wall Junction Blocks	<p>The junctions of the adjoining walls throughout this house have only been constructed with two blocks within them and as a result the corner junction studs have only been fixed to each other at centres of over 1000mm.</p> <p>The relevant Australian Standard, A.S 1684.4-2006 Residential Timber-Framed Construction - Simplified, clause 6.2.1.3 Wall Junctions states '<i>Internal and external walls shall be fixed together with a minimum of 2/75mm nails at 800mm maximum centres</i>', which would therefore require three fixing points or blocks to be installed down the length of every corner stud.</p> <div style="text-align: center;">

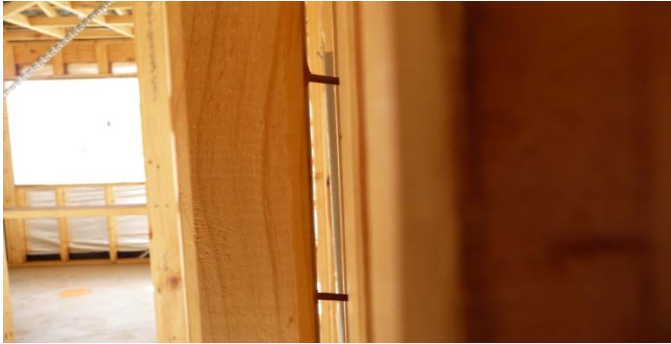
Defective Item	Observations, Considerations and Recommendations:-
Wall Junction Blocks (cont.)

</div> <p>There are also a number of the wall junctions that have not had their studs fixed up tight to each other as can be seen in the following photographs, which will allow these studs to keep moving on the nails and lead to the cracking of the plaster down these internal corners over the longer term.</p> <p style="text-align: right;">cont/.....</p>

<p>All of these corners need to be fully nailed off in compliance with the requirements of A.S 1684.4-2006 at maximum 800mm centres with 2/75mm nails into each face of each block.</p>
Jack Studs	<p>The jack studs over the windows of Bed 2; Lounge; WIR; and the Laundry and Entry doorframe etc. have been installed in the wrong orientation for the brickwork that is installed in front of them to be tied back into this timber framework.</p> <p>The relevant Australian Standard A.S. 3700 – 2001 requires in section 4.10 Wall Ties that <i>'Wall ties for cavity and masonry veneer walls shall be spaced no greater than 600mm in each direction. Adjacent to lateral supports and control joints, and around openings in the masonry, with <u>the first line of ties located within 300mm from the top of the wall, control joint or perimeter of opening</u>'.</i></p> <p>The orientation of these jack studs must be rectified and the brickwork properly tied back to the framework as required by the BCA.</p>

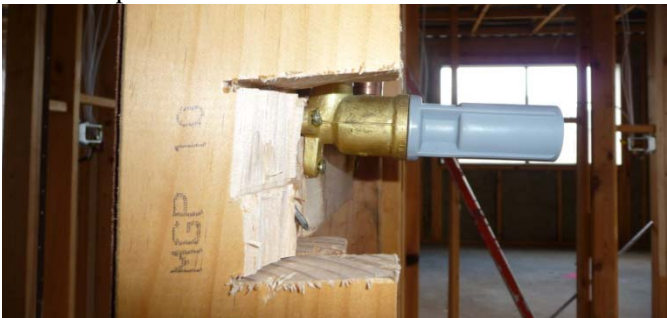
Notches in Studs	<p>The stud in behind the Bathroom shower tap has been notched into by up to 45mm to allow for the installation of the tap set.</p>

Defective Item	Observations, Considerations and Recommendations:-
Notches in Studs	<p>A.S 1684.2-2006 Residential Timber-Framed Construction, clause 6.2.1.4 Notching, Trenching and Holes in Studs and Plates states <i>'the limit of a notch into a studs depth is a maximum of 20mm'</i>.</p> <p>The current studs will need to be trimmed out and additional studs installed down the sides of these tap sets.</p>
Holes in Wall Studs	<p>The studs in the Ensuite/Laundry walls (x 3); and in the Bathroom walls (x 5) have all had holes drilled through them to accommodate the plumbing pipe work at distances of between approximately 150 to 200mm apart. A number of these holes have also been drilled either side of the notch for the metal wall bracing.</p>

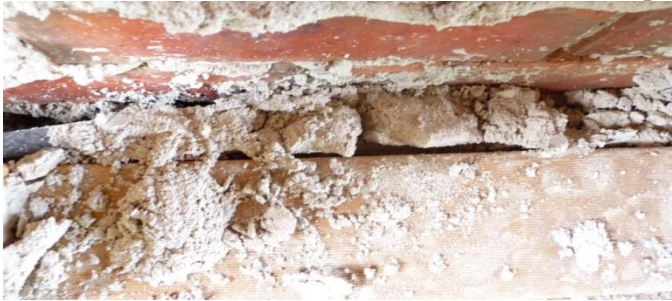
Brickwork	<p>The brickwork up the left hand side of this home overhangs the edge of the slab by up to 35mm.</p> <p>Part 3.2.2.7(b) Edge Rebates of the BCA's states that; 'Exterior masonry must not overhang more that 15mm past the edge of the slab'.</p> <p>Thus section of brickwork will need to be extended using an appropriately designed and certified engineered system.</p>
	<p>There has not been a head flashing installed into the brickwork across the tops of the electrical meterbox.</p> <p>Part 3.3.4.7 Location of Flashings of the BCA's requires that <i>'a flashing must be provided where the cavity is interrupted by a structural element, <u>opening</u> or the like'</i>.</p> <p>This flashing must be correctly installed to properly water-proof the top of the electrical meterbox.</p>
	<p>The top of the cavity flashings around the Garage have not been fixed to the frame and as a result have rolled forward and now have mortar build up in behind them in a number of places, which will allow water and moisture to transmit across onto the pine wall plates.</p>

<p>Part 3.3.4.8 Flashings at the Base of Cavity Walls, of the BCA's states that; <i>'A flashing at the base of a cavity masonry or masonry veneer wall, must extend across the cavity and be turned up not less than 150mm <u>and fixed to the frame</u>'</i>.</p> <p>All of the loose mortar will need to be removed from behind these flashings and them properly fixed back to the frame.</p>
