New Home Inspections

BUILDING INSPECTION REPORT AND DEFECTS LIST

Lot 32 No. 5 Sample Ave, Sampletown North

Date of Report – Wednesday 4th September 2013

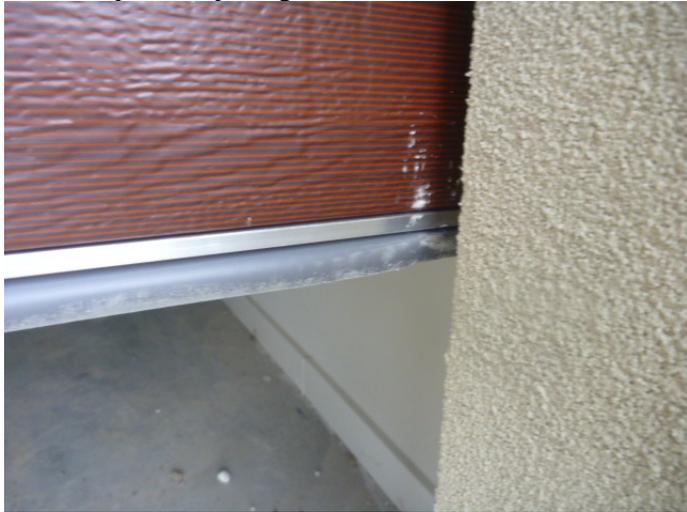
Item	Observations, Considerations and Recommendations:-	
1.	Garage Door	<p>The colorbond door has had its prefinished painted coating scratched through down each side on the rear face of the piers, exposing the base metal.</p>

<p>BlueScope Steel, the manufacturer of colorbond steel state on their web site that –‘BlueScope steel does not recommend the use of touch up paints on Colorbond steel’ and that ‘Our recommendation is not to touch up. Minor scratching will not affect the life of the sheet and is rarely obvious to a casual observer. Should damage be substantial, replace the sheet. We particularly recommend against the use of spray cans, as these can result in overspraying of surrounding areas. The problem might not be immediately obvious, but since overspray paint weathers at a different rate to the oven dried paint on Colorbond steel you’ll eventually be left with an unsightly blemish on the sheet’.</p> <p>The affected damaged sections will need to be replaced.</p>

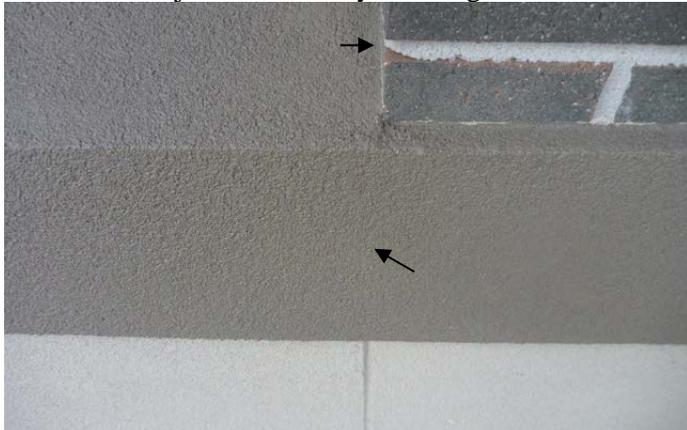
3.		<p>The rendered band that has been applied across the walls of this house has been applied directly across each articulation joint, effectively blocking them and the sill sections.</p>

Item	Observations, Considerations and Recommendations:-	
	<p>Articulation joints are the vertical gaps constructed into brickwork to absorb the expected structural movement of the buildings foundation material, and just as importantly to act as control joints to absorb the expected growth/shrinkage in clay or concrete bricks.</p> <p>Part 3.3.1.8 Vertical Articulation Joints, of the BCA requires that <i>‘Vertical articulation joints must be provided in un-reinforced masonry walls and must have a width of not less than 10mm.’</i></p> <p>With each of the articulation joints full of render, these walls have no ability to move in a controlled manner and will therefore most likely crack at other points along the walls.</p> <p>In addition to this the Building Commission’s Guide to Standards and Tolerances clause 9.04 Articulation or Control Joints – Provision and Cracking, states- <i>‘With the exception of paint and recommended mastic sealants, render or other applied finishes are defective in they cover articulation or control joints’</i> and clause 9.05 Covering Articulation or Control Joints and Damp-proof Courses, states- <i>‘Mouldings and inflexible covering strips are defective if they are installed across articulation or control joints and are fixed or restrained on both sides’</i>.</p> <p>These articulation joints must be fully cut through the render finish and sill sections, after which they should be sealed with a matching coloured flexible acrylic sealant.</p>

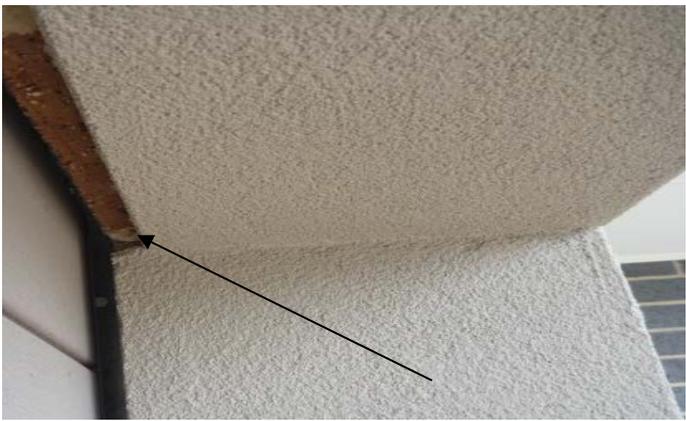
4.		<p>The render across the front of the Garage has not been finished off in behind the door opening lintel, which will need to be rectified.</p>

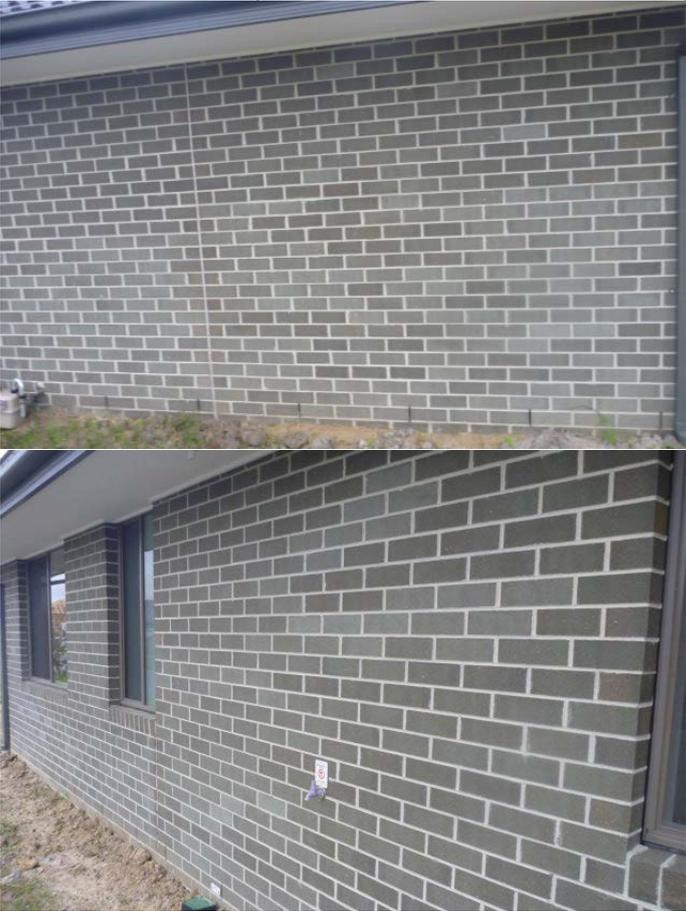
5.	Brickwork	<p>The bricks within the walls of the Garage and house have not been blended properly.</p>

Item	Observations, Considerations and Recommendations:-
	<p>The Building Commissions, Guide to Standards and Tolerances clause 3.06 Blending and Matching of Masonry – New Work’ states that ‘Masonry areas that vary in colour are defective if the units are not mixed and/or distributed in accordance with the manufacturer’s installation instructions’.</p> <p>Blending refers to the process of mixing the bricks to evenly distribute the product colours across the entire finished wall.</p> <p>Blending instructions are supplied on the sides of brick packs when delivered and recommend:-</p> <ol style="list-style-type: none"> 1. Work from at least three open packs at any one time; and 2. Select the top bricks from the left of each pack; and 3. Work progressively from a corner across and down each pack in a diagonal pattern. Do not unpack the bricks in horizontal layers. <p>Clearly the blending of the bricks within these walls has not been carried out correctly and now will have to be rectified.</p>

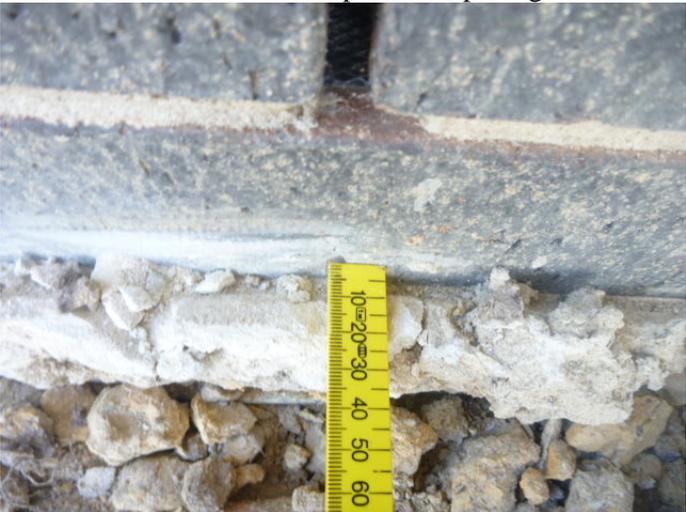
Item	Observations, Considerations and Recommendations:-
12. Concrete Floor Slab	<p data-bbox="411 123 1517 192"><i>building or rigid structure. Isolation joints should allow freedom of movement between the pavement and the structure’.</i></p> <p data-bbox="411 208 1342 243">The current paving installation is incorrect and must now be properly rectified.</p> <p data-bbox="411 243 1517 408">The lower edges of the concrete slab had not been correctly boxed out prior to this floor being poured, which has resulted in the concrete protruding out past the face of the brickwork by up to 30mm across the front wall of the Ensuite; down the left hand side of the Rumpus and Bed 3; down the entire right hand side; and up to 60mm across the rear of Bed 4, which will foul the installation of the future perimeter paving and landscaping.</p>

<p data-bbox="411 920 1517 1019">As the builder has constructed this slab with a two brick rebate, the damp-proof course/cavity flashing has been installed on top of the bottom brick or only approximately 85mm above this blow out of concrete.</p> <p data-bbox="411 1035 1517 1340">Given that Part 3.3.4.5 (c) of the BCA, Damp-proof course-installation states that <i>‘the height of a damp-proof course, or flashing serving as a damp-proof course, must be not less than 150mm above the adjacent ground level; or 75mm above the finished surface level of adjacent paved, concreted or landscaped areas that slope away from the wall’</i>, the owners currently have no way of finishing their paving and gardens neatly up to the side faces of this slab or the walls of their house, while maintain the minimum distance down from the damp-proof course as required by the BCA. Additionally, the reactivity of the soils in this area and the expected differential movement between the house slab and the areas outside it will also contribute to difficulties in the placement of the surrounding paving and gardens.</p> <p data-bbox="411 1356 1517 1556">The builder should therefore, after consultation with the slabs design engineer, trim all of the blown-out areas of concrete back to be in alignment with the finished face of the brickwork so that the paving and landscaping can be neatly finished up beside it. Consideration and care must be paid to not fracturing the concrete and breaking the bond between it and the reinforcement; not reducing the throat of the edge beam; and to not exposing the steel reinforcement or reducing its side cover.</p>

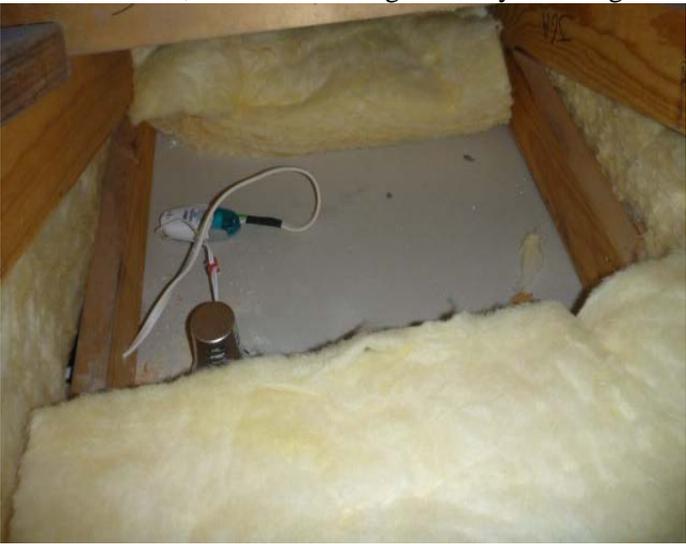
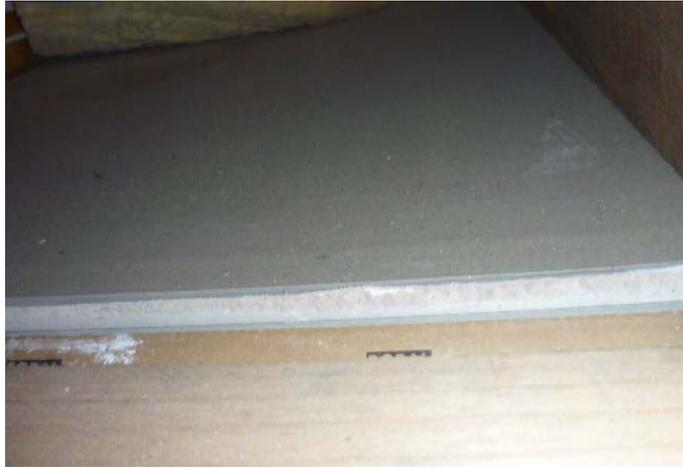
13. Roof Cavity	<p data-bbox="411 1556 1517 1655">The ceiling insulation has not been installed around the light fitting snugly enough and has currently been left up to 400mm away from the sides of the downlights; as well as up to 200mm away from the side walls, which will be significantly reducing its effectiveness.</p>

Australian Standard A.S. 3000:2007 Wiring Rules only require that insulation be kept 200mm away from halogen downlights as per Figure 4.7, shown below-

The present insulation must be rectified so that it is fitted around the light fittings correctly as required by Australian Standard AS/NZs 3000:2007 Wiring Rules to achieve the required R-value and across the entire ceiling area.

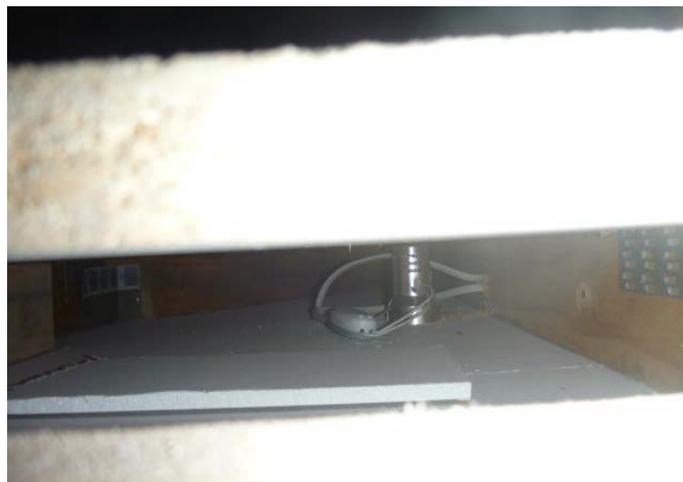
15. There is an unshielded downlights in the rear passage that has been installed directly under the heater walkway and will need to be rectified to comply with the clearances detailed in Item 13 of this report.

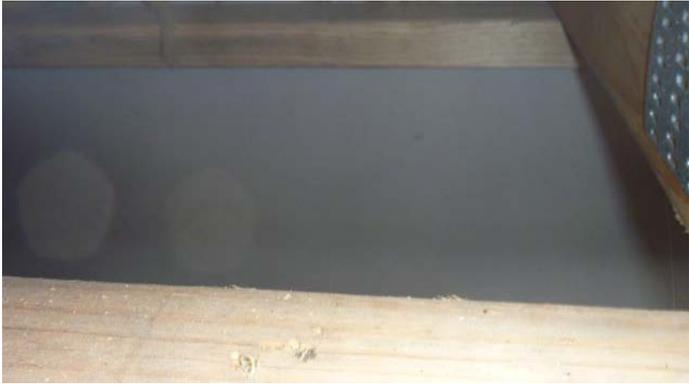
17.	<p>The switch for the light to the heating unit is located at least 3 metres from the access opening.</p> <p>The relevant Australian Standard A.S. 5601 – 2004 Gas Installations, clause 5.3.11 Appliances in Roof Spaces (f), requires that <i>'Permanent artificial lighting is to be provided at the appliance, with the switch located adjacent to the access opening'</i>.</p> <p>This light switch will need to be moved to be adjacent to the access opening as required.</p>

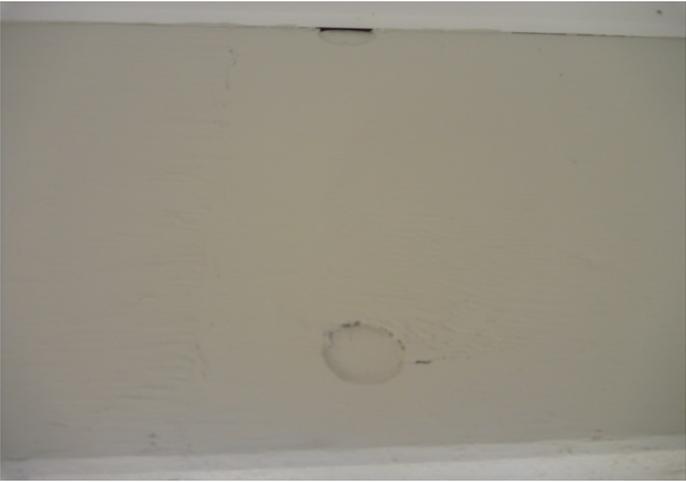
20.	<p>The inside faces and bottom edges of the roof beams around the Alfresco area contain splits and open knots holes within their veneer finish.</p>

<p>The Building Commission's Guide to Standards and Tolerances clause 12.04 Mechanical Damage and Natural Defects in Surfaces, states <i>'Holes and any other unfilled depressions in paint or stained timber such as surface defects caused by mechanical damage, natural characteristics such as gum pockets or surface splits are defects if they can be seen from a normal viewing position'</i>. A normal viewing position would be at a distance of 1.5 metres or greater back from these beams.</p> <p>The splits and holes along these beams need to be properly filled before being properly sanded and repainted.</p>

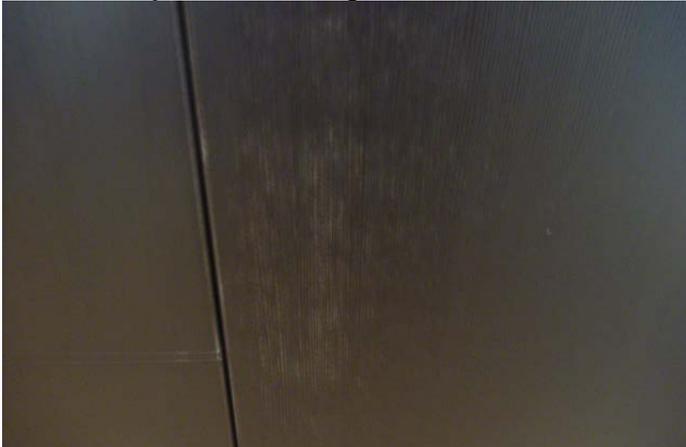
28.		The surface of the shower base needs to be properly re-polished to remove the present scratches from across it.
29.		<p>The lacquer finish on the vanity doors is lacking, which will need to be recoated.</p>

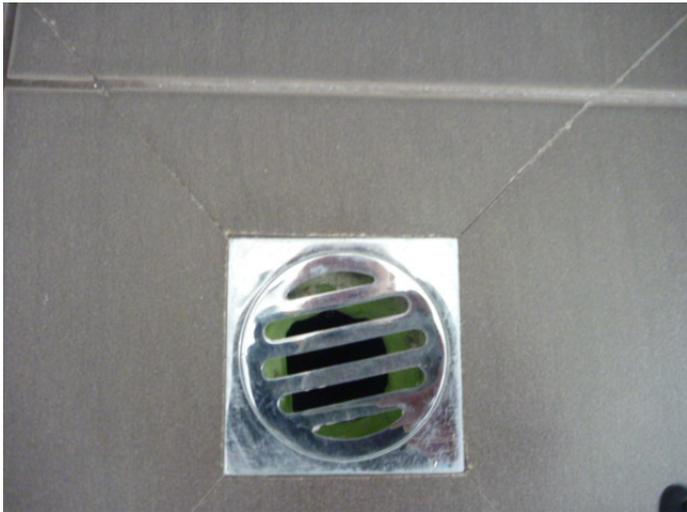
39.	<p>Bathroom</p> <p>The surface of the bath needs to be properly re-polished to remove the present scratches from across it.</p>
40.	<p>Shower Bases</p> <p>The diagonal cuts in the shower floor tiling for the fall to the waste in the Ensuite and Bathroom are tight together and not consistent with the widths of the other grout joints across these floors.</p>

<p>The relevant Australian Standard A.S. 3958.1 – 2007 Ceramic Tiles – Guide to the Installation of Ceramic Tiles, clause 5.4.6 Tile Finish and Joints also states that <i>'Joint widths should be consistent throughout the installation unless otherwise specified. The recommended joint widths for floors with dust-pressed tiles are 3mm, measured at the tile face'</i> and clause 5.4.3 – Fitting, states that <i>'Keep all joint lines, including mitres, straight and of even width'</i>.</p> <p>These tiles and the grout joint widths must be properly rectified or replaced.</p>
