# **New Home Inspections**

## **FRAME STAGE INSPECTION REPORT AND DEFECTS LIST**

**Address of Subject Property:**  
Lot 55 Sample Pde, Sampleville

**Date of Inspection – Monday 9<sup>th</sup> September 2013**

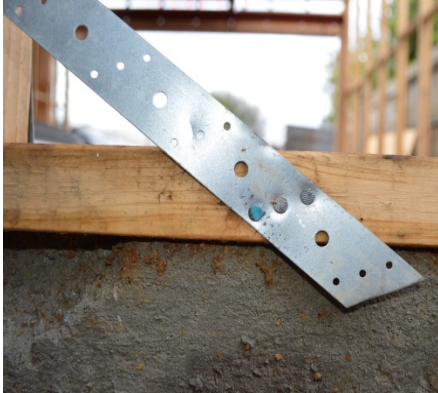
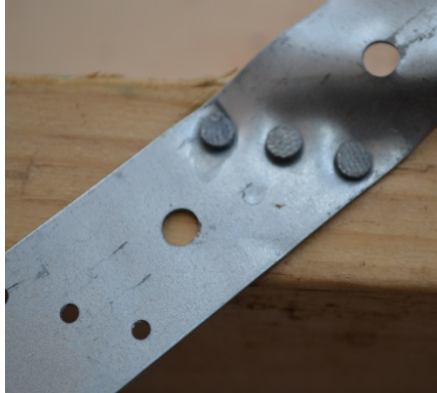
Item	Observations, Considerations and Recommendations:-
1. Approved Engineering Design Issues	<p>From the engineering drawings that I was provided with, the following items have not been constructed on site as set out and detailed within them-</p> <ol style="list-style-type: none"> <li>i. The specified prop has not been installed under 1L7 beneath 1B13.</li> <li>ii. The specified prop has not been installed under 1B10.</li> <li>iii. The specified 2no. F17 KDHW studs to be installed under 1B12 have been installed using ordinary pine studs.</li> <li>iv. The specified oversized washers have not been installed on the bolts through 1B1 and 1B2 to the timber face of these beams.</li> <li>v. The trimmers to the Kitchen window have not been nailed at the specified 300mm centres staggered along their top and bottom faces.</li> <li>vi. Only 2no. of the 4no. specified trip-l-grips have been installed between each end of the Kitchen window trimmers to the opening studs.</li> <li>vii. The specified seat section of the cleat has not been provided to the L1 junction to the C1 column.</li> <li>viii. The second specified 150 x 100 x 10 bracket has not been installed between the junction of 1B10 to 1B12.</li> <li>ix. The specified oversized washers have not been installed on the bolts through 1B10 to the timber face of this beam.</li> <li>x. The second specified 100 x 100 x 10 bracket has not been installed between the junction of 1B11 to 1B12.</li> <li>xi. The specified oversized washers have not been installed on the bolts through 1B11 to the timber face of this beam.</li> <li>xii. The specified oversized washers have not been installed on the bolts through 1B9 and 1B10 to the timber face of these beams.</li> <li>xiii. 1B11 has not been strap braced down to the studs supporting in as specified.</li> <li>xiv. All of the BR3 braces have been fixed into the top and bottom plates with only 3no. nails instead of the 4no. specified.</li> </ol> <div style="display: flex; justify-content: space-around;">

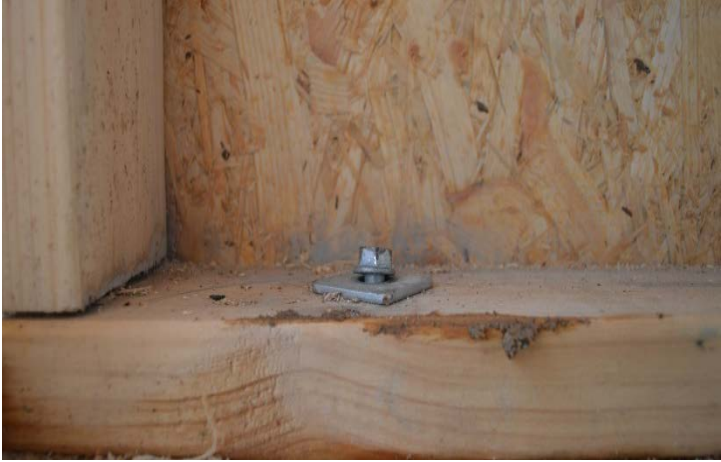
</div> <ol style="list-style-type: none"> <li>xv. The specified 1.1m wide BR4A type brace on the left hand side of the Porch has not been installed.</li> <li>xvi. The specified 1.3m wide BR4 type brace on the front wall of the Guests Bed WIR is only 1.17m long.</li> <li>xvii. The left hand side Ankascrew in the above brace is not down tight to the bottom plate.</li> </ol> <div style="text-align: center;">

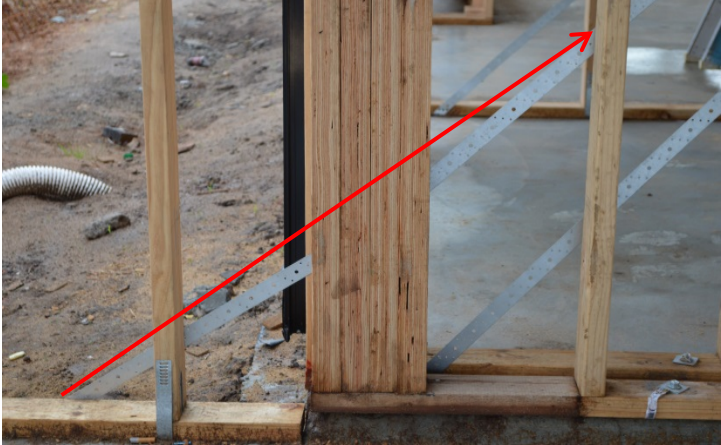
</div> <ol style="list-style-type: none"> <li>xviii. The BR3 brace on the Garage/Laundry wall is not straight.</li> </ol>

<p>xix. The specified Anka-screw needs to be installed to the Garage rear wall bottom plate at the end of the above brace panel.</p> <p>xx. There have been no Anka-screws installed into the bottom plate of the BR3 braced wall between the Laundry and the Stairwell.</p> <p>xxi. The BR4A brace on the side wall of the Guests Bed WIR needs to be trimmed across under the meterbox so that the plywood brace can be fixed sufficiently.</p> <p>xxii. The specified BR4A type brace on the Rumpus side wall has not been installed.</p> <p>xxiii. The specified 1.2m wide BR5 type brace on the rear wall of the Rumpus (boundary side of the window) is only 1.1m long.</p> <p>xxiv. The Anka-screws through the bottom plate of the above brace are up to 180mm away from the end of the brace panel instead of within the max. 100mm specified.</p> <p>xxv. The specified 1.2m wide BR5 type brace on the rear wall of the Rumpus (Alfresco side of the window) is only 1.165m long.</p> <p>xxvi. The tops of the Garage/Laundry and Guests Bed/ENS braced walls need to be fixed into the floor joist with shear block fixings for the equivalent capacity of the brace type as per clause 8.3.6.9 Fixing of Top of Bracing Walls of AS 1684 Residential Timber-Framed Construction.</p> <p>xxvii. The shear blocks installed over the Master robe/Bed 2 wall are in the wrong orientation as to that specified on Drawing No. 13 and AS 1684 Residential Timber-Framed Construction.</p> <p>xxviii. The specified shear blocks have not been installed over the Retreat/WIR wall.</p> <p>xxix. The specified shear blocks have not been installed over the Activity/ENS wall.</p> <p>xxx. The specified shear blocks have not been installed over the Bath/Retreat wall.</p> <p>xxxi. The specified shear blocks have not been installed over the Bed 2/Stairwell wall.</p> <p>xxxii. The specified shear blocks have not been installed over the Stairwell/WIL/WIR wall.</p> <p>All of these items will need to be re-constructed on site to reflect the designed requirements of the approved drawings or otherwise re-computed and certified by the original design engineer. The original building permit may also need to be amended by the relevant Building Surveyor to reflect the changes to the original approved drawings.</p>

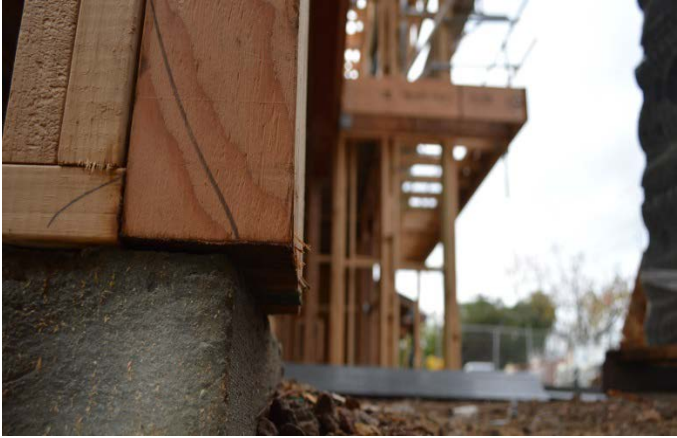
2.	<p>Floor Slab</p> <p>The floor slab has been boxed and poured short across the front left hand side of the Garage, which has left the bottom of the wall studs overhanging the edge of the slab by up to 30mm.</p>

<p>The Building Commission's Guide to Standards and Tolerances clause 4.08 Bottom Plates that Overhang Concrete Slabs, states '<i>Bottom plates that are at least 90mm wide and overhang concrete slabs are defective. An overhang of up to 10mm is permissible</i>'.</p>

Item	Observations, Considerations and Recommendations:-
3.	<p>This overhanging bottom plate will need to be supported by an appropriately designed and certified engineered system so that it complies with this tolerance.</p> <p>The floor slab has been boxed and poured short across the rear wall of the Garage at the step-down from the Laundry, which has left the bottom plate of the wall frame overhanging the edge of the floor slab by up to 13mm under the combined four stud point load.</p> <p>The Building Commission’s Guide to Standards and Tolerances clause 4.08 Bottom Plates that Overhang Concrete Slabs, states ‘<i>Bottom plates that are at least 90mm wide and overhang concrete slabs are defective. An overhang of up to 10mm is permissible</i>’.</p> <p>This overhanging bottom plate will need to be supported by an appropriately designed and certified engineered system so that it complies with this tolerance.</p>

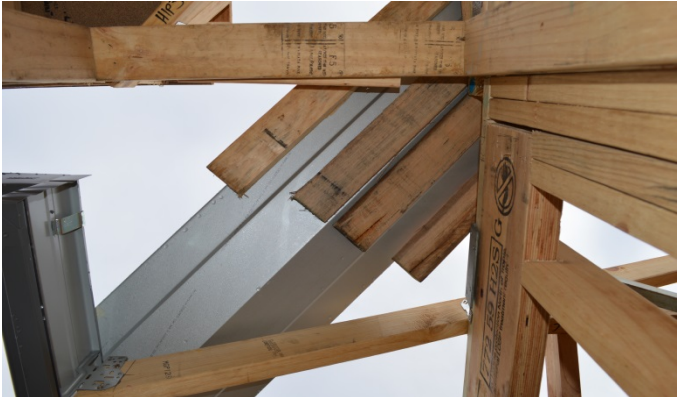
6.	<p>The bottom edges of the valley boards need to be extended to the fascia as well as being supported between the trusses so that they and the valley iron are properly supported.</p>

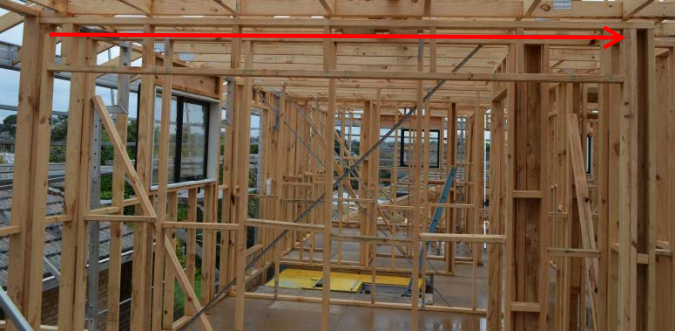
7.	<p>The 3600mm wide opening above the robe doors in the Master Suite does not contain a lintel to support the top plate that run across it.</p>

<p>It is a requirement of Australian Standard, A.S 1684 Residential Timber-Framed Construction, clause 6.3.6.5 Lintels in Non-Loadbearing Walls, that <i>'For internal walls where ceiling loads are not supported and wall openings are wider than 1800mm, the size of the lintel shall be determined from Span Table 23 using a ceiling load width of 1800mm'</i>.</p> <p>The builder must establish the correct sized lintel for this opening (170 x 35 MGP10 or similar) and install it into it, in compliance with this requirement of A.S 1684.</p>

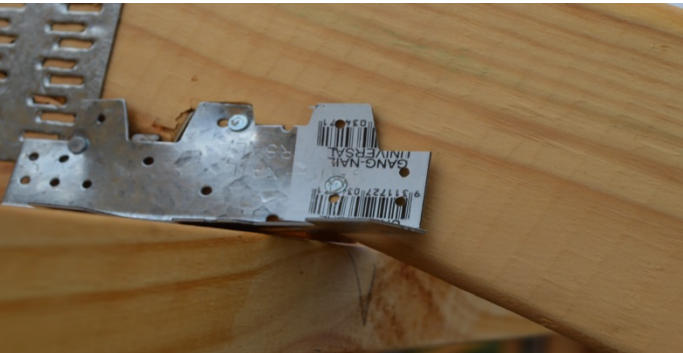
8.	<p>The trip-l-grips fitted to hold the roof trusses down only have two or three nails into the side of the trusses and top plates but have not been bent down the sides of the top plate and fixed with the required additional four nails into the sides.</p>

<p>The manufacturer's installation guidelines require four nails into the side of the top plates, two into the top of the top plate, and four into the side of the truss, as per their detail below-</p> <p><b>TRIP-L-GRIP</b></p>

<p>The trip-l-grips need to be correctly fitted with the required number of nails fitted through each face.</p>

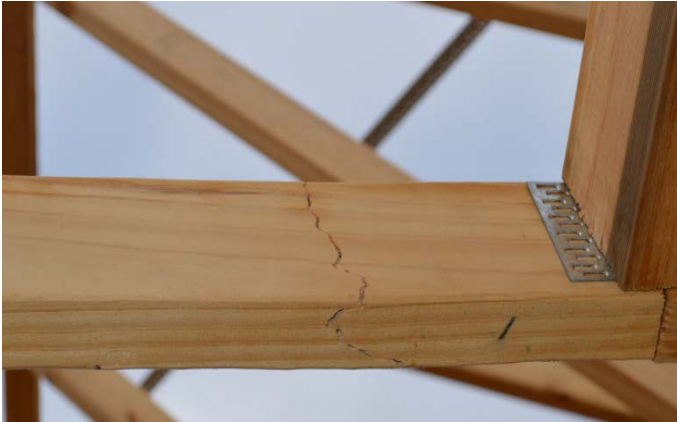
9.	<p>The bottom chord of the truss over the Bed 2 WIR/Master Suite wall has a crack through it and will need to be repaired under its manufacturer's instruction.</p>

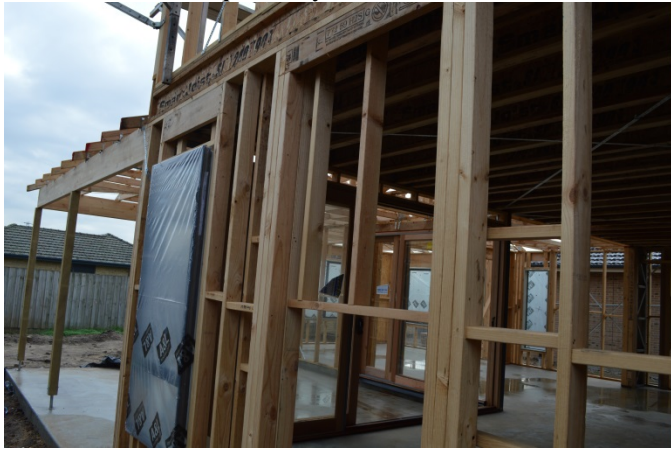
10.	<p>The outer wall skin over the Living firebox needs to be installed so that the brickwork can be properly tied back to the frame as required by the BCA.</p>

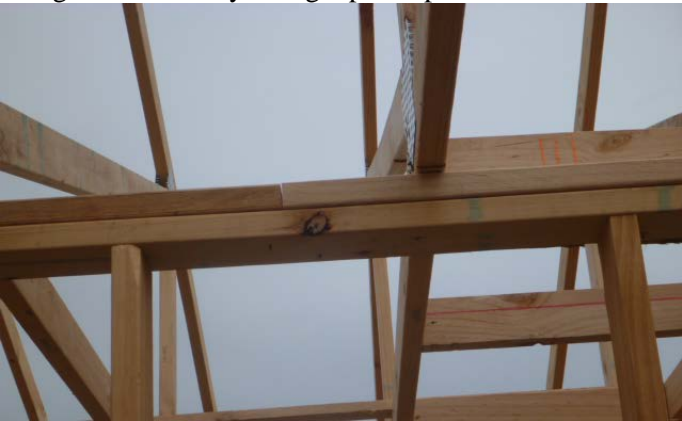
11.	<p>There is a truss over the Bed 2/Living wall that is up to 250mm away from over a supporting wall stud and there is an unsupported join in one of the double top plates between the wall studs, thereby reducing it back to only a single plate span.</p>

<p>It is a requirement of Australian Standard, A.S 1684 Residential Timber-Framed Construction, clause 2.4 Stud/Plate Lamination, that <i>'where joints occur in either top plate between studs, and where rafters or trusses bears onto top plates, additional blocking shall be provided (see Figure 2.9).'</i></p> <div style="text-align: center;">

<p><b>Figure 2.9 Stud/Plate Lamination</b></p> </div> <p>The join in this top plate must be properly rectified in accordance with the above.</p> <p style="text-align: center;">-:End of Schedule:-</p>
