New Home Inspections

MAINTENANCE STAGE INSPECTION REPORT AND DEFECTS LIST

Lot 5 No. 32 Sample Cct, Sample Heights

Date of Inspection – Tuesday 17th September 2013

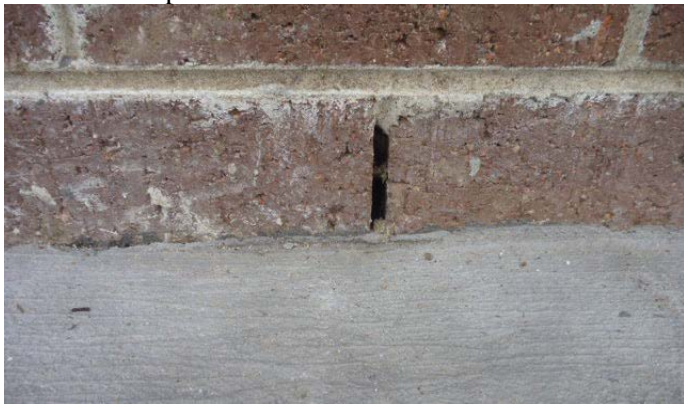
2.	Paving	<p>The paving that has been installed across the front wall of this home is over the front edge of the damp-proof course and weepholes.</p>

<p>It is a requirement of Part 3.3.4.5 Damp-proof course-installation of the BCA, that – <i>‘the height of a damp-proof course must be not less than 75mm above the finished surface level of adjacent paved, concreted or landscaped areas that slope away from the wall.’</i></p> <p>The placement of this paving must be rectified by the builder.</p>

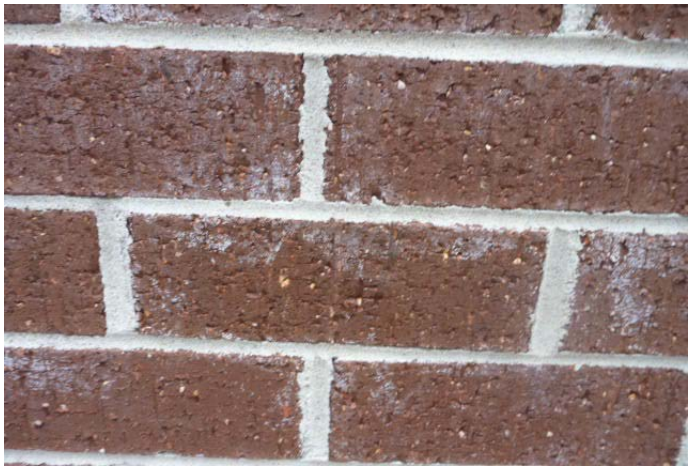
7.		<p>There are many areas around the walls of this house and garage that are displaying insoluble white deposits on the faces of the bricks.</p>

<p data-bbox="411 599 1517 730">There are a number of causes of this problem, the most common from when too much acid and not enough water is used in the initial clean, which causes the by-products of the reaction between the acid and the mortar to be absorbed into the brick faces instead of being washed clear of the wall.</p> <p data-bbox="411 743 1517 810">These walls will have to be re-cleaned with a product approved by the brick manufacturer to remove this staining.</p>
