New Home Inspections

PRE PLASTER INSPECTION REPORT AND DEFECTS LIST

Address of Subject Property:
Lot 55 Sample Dr, Point Sample

Date of Inspection – Wednesday 11th September 2013

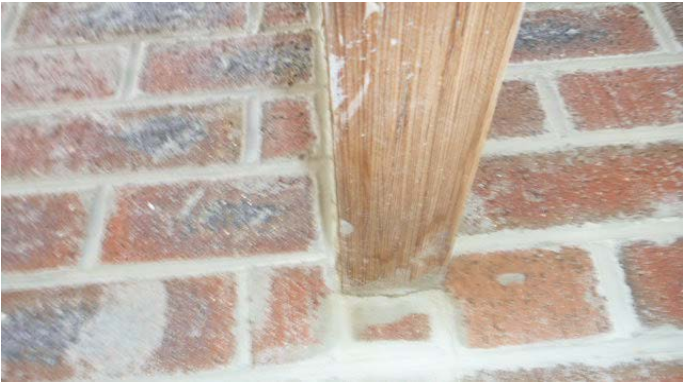
3.	<p>Brickwork</p> <p>The brickwork had been installed hard up to the underside of the roof beams around the Alfresco area.</p> <div style="text-align: center;">

</div> <p>Part 3.3.1.10 Shrinkage Allowance for Timber Framing of the BCA requires that <i>'In masonry veneer walls a gap must be left between the timber frame and the top of the masonry wall, including window sills ect, to allow for settlement of the timber framing caused by timber shrinkage. These clearances must be not less than 5mm at sills of lower and single storey windows; and 8mm at roof overhangs of single storey buildings'</i>.</p> <p>The brickwork below these beams will need to be lowered to achieve the required 8mm clearance.</p>

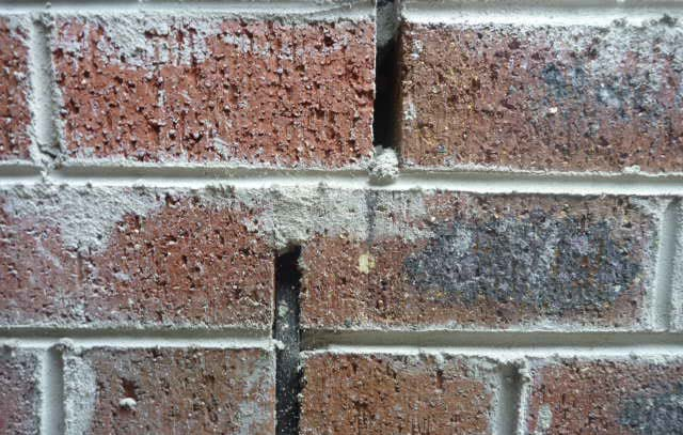
Item	Observations, Considerations and Recommendations:-
	<p>I note the following deficiencies in the correct installation of the articulation joints around this home:-</p> <ol style="list-style-type: none"> The articulation joint nominated on the approved plans to be installed between the side wall of the Master Bedroom and the Ensuite wall projection beside it has not been installed. The articulation joint nominated on the approved plans to be installed over the right hand side of the left hand Porch isolated pier up through the Balcony wall brickwork has not been installed. The articulation joint nominated on the approved plans to be installed beside the Kitchen window has not been installed. The articulation joint nominated on the approved plans to be installed to the left side of the front Games room window does not extend up through the brickwork over the window frame. The articulation joint installed beside the left side of Bed 3's window is breached and not continuous down the entire wall within the Rumpus room roof line.

<p>These omitted or incorrectly installed articulation joints will stop the ability of the individual sections of these walls from being able to move independently to each other as they experience the expected footing movement and brick growth.</p> <p>The builder must therefore properly rectify/installed these articulation joints, with attention given to adequately tying the walls on each side of the joints back to the timber framework at maximum 300mm centres in accordance with the requirements of the relevant Australian Standards/BCA, which state-</p> <p>Australian Standard A.S. 3700 – 2001 requires in section 4.10 Wall Ties that <i>'Wall ties for cavity and masonry veneer walls shall be spaced no greater than 600mm in each direction. Adjacent to lateral supports and control joints, and around openings in the masonry, with the first line of ties located within 300mm from the top of the wall, control joint or perimeter of opening'</i>. Additionally, section 11.4.7 Building In requires that <i>'Wall ties and accessories embedded in masonry joints shall be built in as the construction proceeds'</i>.</p>

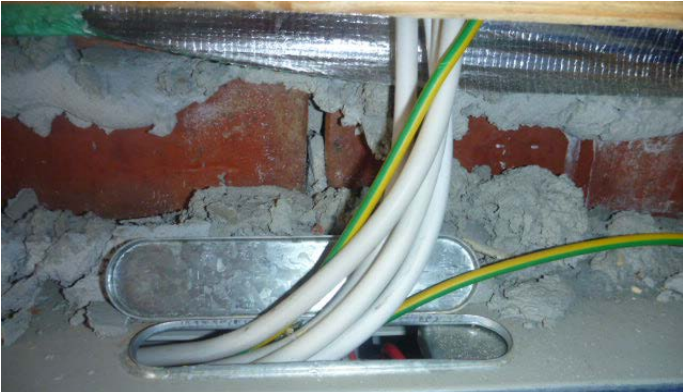
5.	<p>There has not been a cavity flashing installed inside the brickwork over the electrical meterbox.</p>

<p>Part 3.3.4.7 Location of Flashings of the BCA's requires a flashing must be provided where the cavity is interrupted by a structural element, <u>opening</u> or the like.</p> <p>This flashing must be properly installed to water-proof the top of the electrical meterbox and to stop the possibility of the ingress of any water into it.</p>

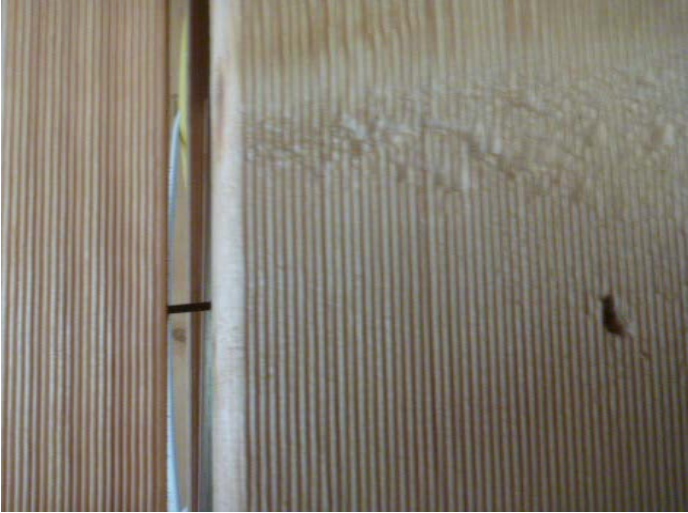
8.	<p>Lock Up Issues The corner studs at the junction of each adjoining wall throughout this house have only been fixed with one nail into each corner block and these fixings are presently spaced at up to 950mm centres. Additionally, not all of the corner studs have been pulled up tight to the blocks they are fixed into, which will lead to the future cracking down these internal plastered corners.</p>

<p>The relevant Australian Standard, A.S 1684 Residential Timber-Framed Construction - Simplified, clause 6.2.1.3 Wall Junctions states '<i>Studs at wall junctions and intersections shall be in accordance with one of the details shown in Figure 6.3</i>'.</p>

<p>FIGURE 6.3 TYPICAL WALL JUNCTIONS</p> <p>And also that '<i>Internal and external walls shall be fixed together with a minimum of <u>2/75mm nails at 900mm maximum centres</u></i>'.</p> <p>All of these corner studs need to be pulled up tight to each other and have additional nails fixed through them to within the 900mm maximum spacing, to stop the future cracking of the internal plastered corners.</p>

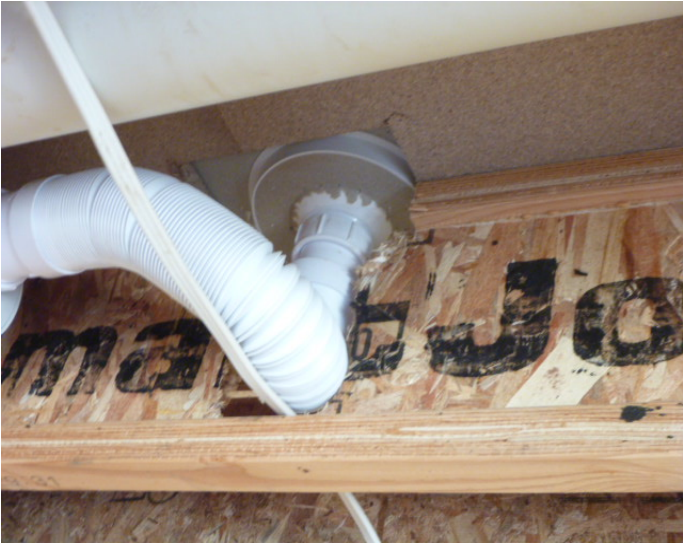
11.	<p>The top flange of the SmartJoists over the Meals area has been cut through for the installation of the shower waste.</p>

<p>The SmartJoists installation instructions clearly warns:-</p>

<p>DO NOT CUT OR NOTCH FLANGES DO NOT OVER CUT HOLES IN WEB</p> <p>This SmartJoist will have to be properly rectified under the instruction of their manufacturer who should supply the detail for the required rectification work.</p>

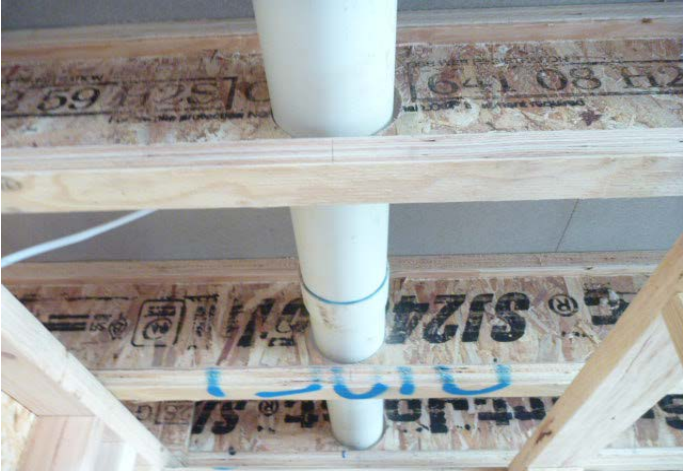
12.	<p>There have been 240 x 51 SmartJoists installed as the first floor joists across the Kitchen area of this home. There have been circular holes with a diameter of up to 115mm drilled through the webs of the joists over the Pantry area that are approximately 300mm out from the internal load-bearing wall.</p>

<p>The manufacturer's Hole Chart states that the <u>minimum</u> distance out from a supporting wall that holes of this size can be drilled through the webbing of joists over this span is 1300mm. The manufacturer notes in this chart state that these spacings are conservative and that the most accurate method for the design of web penetration sizes and distances is by their software.</p> <p>As the present spacings of these sized holes breach the manufacturers Hole Chart the builder should confirm the acceptability with the manufacturer and either rectify these joists as directed or supply the manufacturers certification of the present as built situation back to the owner.</p>

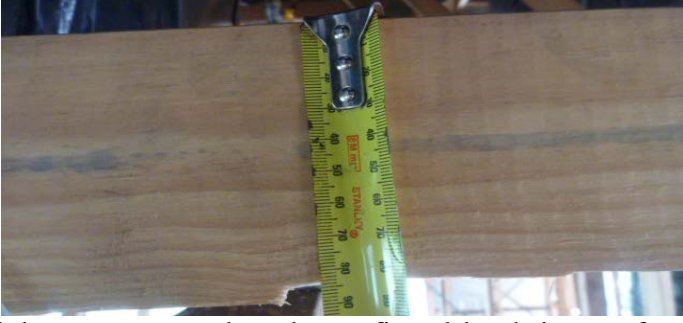
13.	<p>There are two trusses across the Bed 3/TV area wall that have had their 90mm bottom chords reduced back to only 83mm to straighten the ceiling lines.</p>

<p>The adequacy of these trusses needs to be confirmed by their manufacturer or otherwise rectified under their instruction.</p>

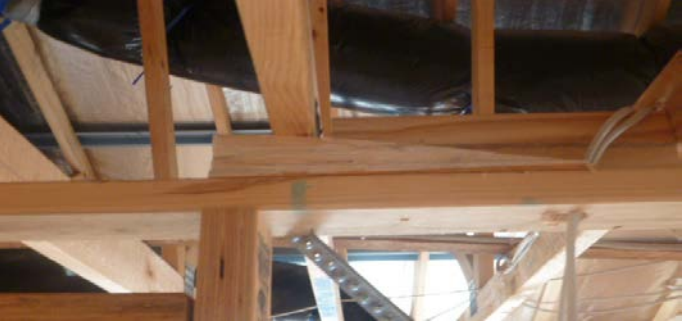
17.	<p>The trusses along the Games/Bed 4 wall have been blocked up off the top plates to align the ceiling, a practice that will now stop the trusses from being able to deflect as they were designed too; as well as now making the internal non load-bearing walls load-bearing.</p>

<p>The relevant Australian Standards A.S 1684 Residential Timber-Framed Construction, states in section 6.2.5.2 Internal Walls – Trussed Roofs, that '<i>Non Load-bearing walls shall be kept a <u>minimum of 10mm</u> below the underside of the bottom chord, or ceiling battens when used</i>'. While A.S. 4440 Installation of Nail-plated Timber Roof Trusses, state in section 2.2.2 Non Load-bearing Walls, that '<i>Non load-bearing walls, as designated, shall not carry any truss loading and shall not be packed to touch the underside of trusses (see Figure 2.1)</i>'.</p>

<p>FIGURE 2.1 LOADBEARING AND NON-LOADBEARING WALLS</p> <p>A.S. 4440 Installation of Nail-plated Timber Roof Trusses, also state in Appendix B2 Camber, that '<i>Trusses are built with camber to allow for the initial deflection at the take up of load and some creep (i.e. long-term deflection) as the timber settles. Thus, packing to the underside of a truss over a non load-bearing wall may stop these deflections and in turn support the truss in an incorrect position</i>'.</p> <p>This blocking must be removed and the ceiling lines straightened using one of the other available methods.</p>
