New Home Inspections

PRE-POUR SLAB INSPECTION REPORT AND DEFECTS LIST

Address of Subject Property:
Lot 555 Sample Ave, Sampleville

Date of Inspection – Tuesday 1st April 2014

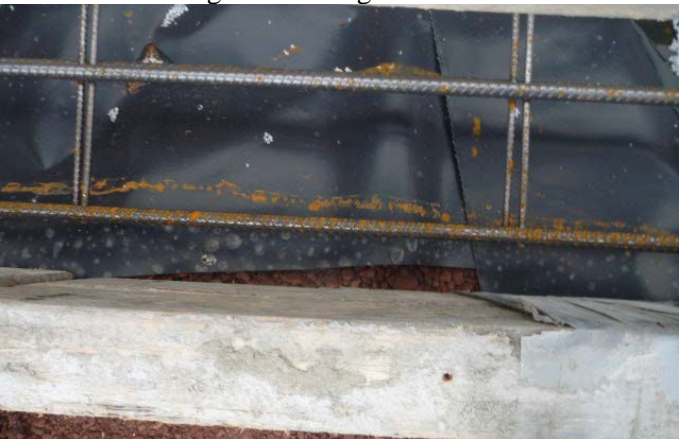
Item	Observations, Considerations and Recommendations:-	
<p>1. Polyethylene Vapour Barrier (Vapour Barrier)</p>	<p>The vapour barrier is short to the edge and boxing across the front of Bed 1.</p>

<p>The relevant Australian Standard AS 2870 Slab & Footing Construction, clause 5.3.3 Vapour Barriers and Damp-proofing Membranes, requires that <i>'Vapour barriers shall be installed so that the bottom surface of the slab and beams, including internal beams, is entirely underlaid. The membrane shall extend under the edge beam to ground level.'</i></p> <p>The vapour barrier membrane in this area will need to be properly extended, lapped and sealed prior to any concrete being poured.</p>	
<p>2.</p>	<p>There are a number of punctures in the vapour barrier membrane under the slab, most noticeably where star pickets have been driven through it at the boxing and/or step downs.</p> <p>It is a requirement of Part 3.2.2.6 Vapour Barriers of the BCA that <i>'A vapour barrier must be fully sealed where punctured (unless for service penetrations) with additional polyethylene film and tape.'</i></p> <p>All of the punctures through the vapour barrier must be properly repaired prior to any concrete being poured. Any penetrating star pickets will need to be removed to achieve this and the step down boxing supported on reinforcement bars bearing onto bar chairs.</p>

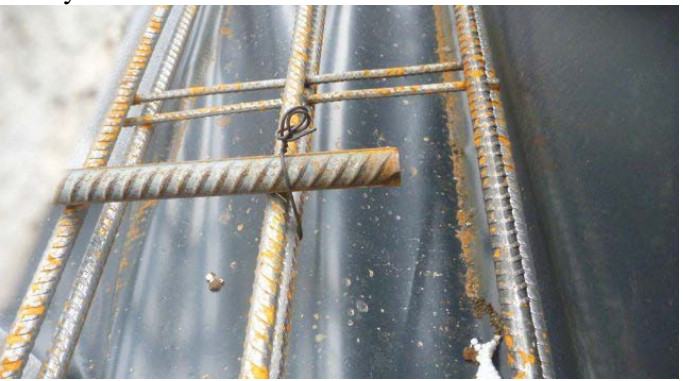
<p>3. Reinforcement</p>	<p>There are a number of the N16 bars from within the internal ribs that do not fully lap the perimeter mesh that they are tied across.</p>

<p>It is a requirement of Part 3.2.3.2 Steel Reinforcement of the BCA that <i>'The minimum lap at "T" intersections for steel reinforcing bars is full width across junction.'</i></p> <p>All of the reinforcing bars will need to be rectified and confirmed as being fully lapped and tied to the perimeter mesh, prior to any concrete being poured.</p>	
<p>4.</p>	<p>The ends of a number of other N16 bars from within the internal ribs, as well as the mesh in a lot of areas, are either touching or are too close to the side boxing.</p>

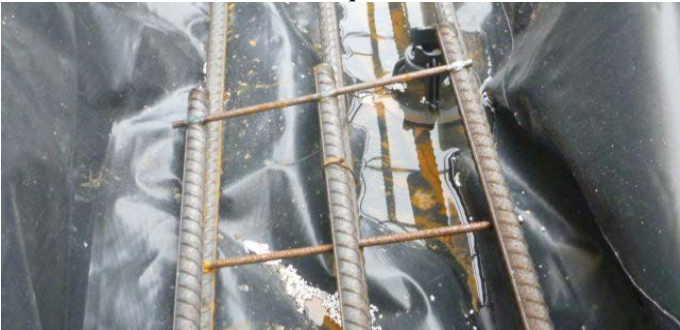
5.	<p data-bbox="413 1701 1528 1802">The bottom mesh along the right hand side of the Garage, within the deepened edge beam is not being properly supported on chairs or cradles and is currently sitting hard down on the vapour barrier in a number of areas, which it requires a minimum 30mm of clearance from.</p>

<p data-bbox="413 2130 1528 2206">The placement of this mesh will need to be properly rectified, prior to any concrete being poured.</p>

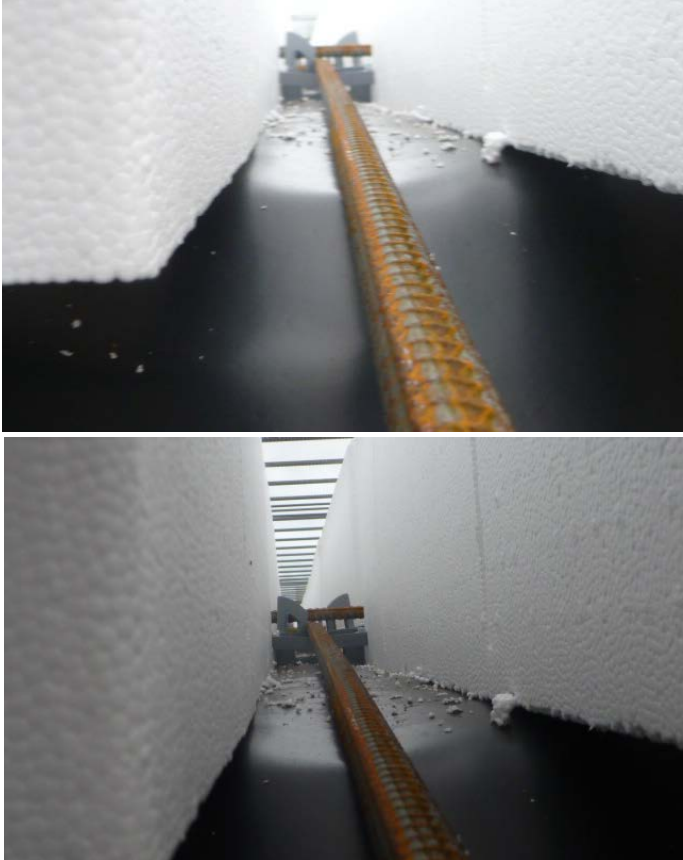
9.	<p>The N16 bars at the bottom of the internal ribs have not been installed and lapped at the step downs as per the approved engineers design but rather run as a continual length through the step downs, which has resulted in them bearing hard down onto the vapour barrier around the Alfresco step down, which it requires a minimum 30mm of clearance from.</p> <div data-bbox="627 1781 1310 2208" data-label="Image"> </div>

<p>TYPICAL STEPDOWN AT INTERNAL RIB DETAIL SCALE = 1:20</p> </div> <p>The formation of the step downs and placement of the reinforcement through them will need to be properly rectified in accordance with the engineers design, prior to any concrete being poured.</p>

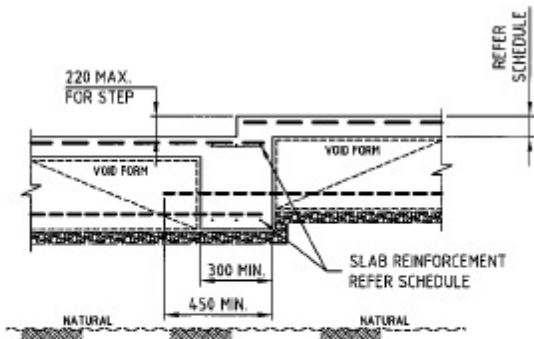
</div> <p>The approved engineers design shows the step down and reinforcement laps should be formed as follows:-</p> <div style="text-align: center;">
