# New Home Inspections

## PRE PLASTER INSPECTION REPORT AND DEFECTS LIST

**Address of Subject Property:**  
Lot 55 Sample Dr, Point Sample

**Date of Inspection – Tuesday 1<sup>st</sup> March 2011**

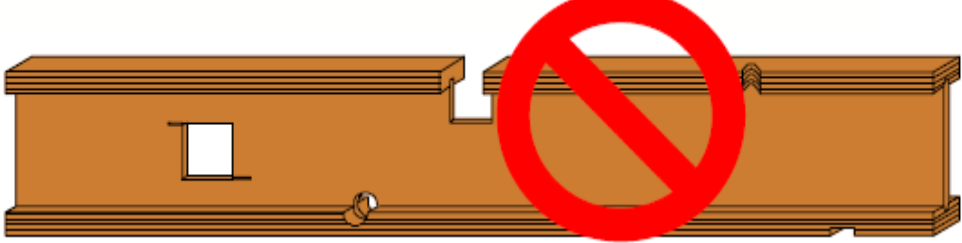
<p>The SmartJoists installation instructions clearly warns:-</p>

<p data-bbox="651 385 1297 472" style="text-align: center;"><b>DO NOT CUT OR NOTCH FLANGES DO NOT OVER CUT HOLES IN WEB</b></p> <p data-bbox="416 491 1520 553">This SmartJoist will have to be properly rectified under the instruction of their manufacturer who should supply the detail for the required rectification work.</p>
