New Home Inspections

FRAME STAGE INSPECTION REPORT AND DEFECTS LIST

Address of Subject Property:
55 Sample Pde, Sampleville

Date of Inspection – Friday 13th March 2009

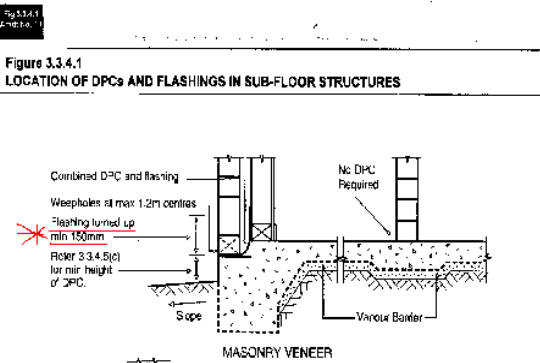
<p>The problem with the current construction detail is that the load-bearing wall plate between these areas is only plain ordinary <u>untreated radiata pine</u>, which has little or no resistance to timber rot.</p> <p>The present construction will leave the damp-proof course/cavity flashing at the same height as the Porch floor, which will allow water and moisture to migrate in under the brickwork and into the pine bottom plates, which will cause it to rot out and fail.</p> <p>Part 3.2.2.7 Edge Rebates of the BCA, requires that <i>'an edge rebate for waffle raft slabs with masonry cavity or veneer construction must not be less than 20mm; and that the edge rebate must be flashed and drained in accordance with Part 3.3.4.'</i></p> <p>Part 3.3.4.5 Damp-proof courses-installation of the BCA requires that <i>'damp-proof courses must be located in accordance with Figure 3.3.4.1 to form a continuous damp-proofing barrier around the building.'</i></p>

<p><i>Note that the damp-proof course is located below the top of the concrete slab.</i></p>
