# **New Home Inspections**

## **FRAME STAGE INSPECTION REPORT AND DEFECTS LIST**

**Address of Subject Property:**  
Lot 55 Sample Pde, Sampleville

**Date of Inspection – Monday 9<sup>th</sup> September 2013**

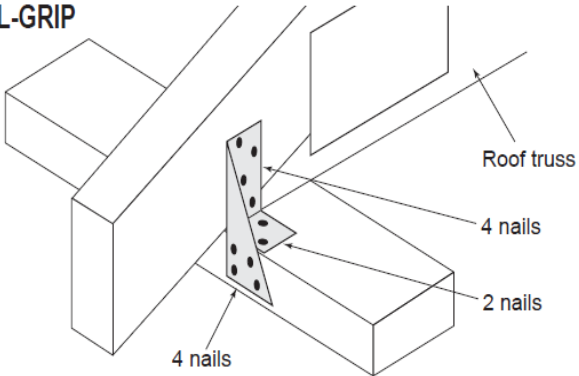
<p>The manufacturer's installation guidelines require four nails into the side of the top plates, two into the top of the top plate, and four into the side of the truss, as per their detail below-</p> <p><b>TRIP-L-GRIP</b></p>

<p>The trip-l-grips need to be correctly fitted with the required number of nails fitted through each face.</p>

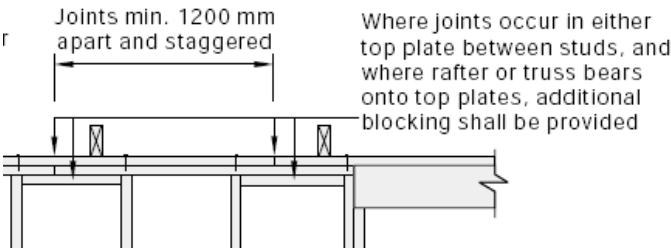
<p><b>Figure 2.9 Stud/Plate Lamination</b></p> </div> <p>The join in this top plate must be properly rectified in accordance with the above.</p> <p style="text-align: center;">-:End of Schedule:-</p>

<p>It is a requirement of Australian Standard, A.S 1684 Residential Timber-Framed Construction, clause 2.4 Stud/Plate Lamination, that <i>'where joints occur in either top plate between studs, and where rafters or trusses bears onto top plates, additional blocking shall be provided (see Figure 2.9).'</i></p> <div style="text-align: center;">
