New Home Inspections

PRE PLASTER INSPECTION REPORT AND DEFECTS LIST

Address of Subject Property:
Lot 55 Sample Dr, Point Sample

Date of Inspection – Wednesday 11th September 2013

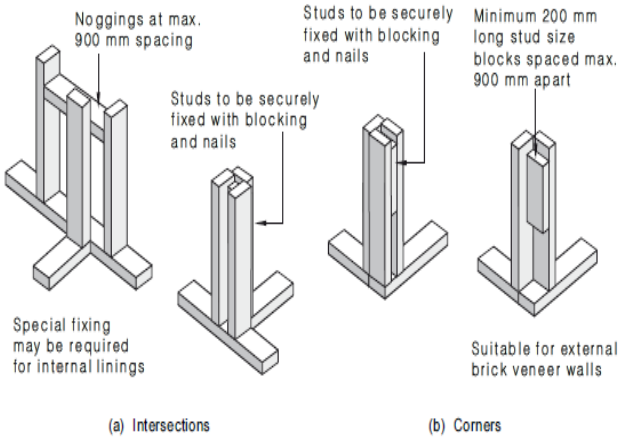
8.	<p>Lock Up Issues The corner studs at the junction of each adjoining wall throughout this house have only been fixed with one nail into each corner block and these fixings are presently spaced at up to 950mm centres. Additionally, not all of the corner studs have been pulled up tight to the blocks they are fixed into, which will lead to the future cracking down these internal plastered corners.</p>

<p>The relevant Australian Standard, A.S 1684 Residential Timber-Framed Construction - Simplified, clause 6.2.1.3 Wall Junctions states '<i>Studs at wall junctions and intersections shall be in accordance with one of the details shown in Figure 6.3</i>'.</p>

<p>FIGURE 6.3 TYPICAL WALL JUNCTIONS</p> <p>And also that '<i>Internal and external walls shall be fixed together with a minimum of <u>2/75mm nails at 900mm maximum centres</u></i>'.</p> <p>All of these corner studs need to be pulled up tight to each other and have additional nails fixed through them to within the 900mm maximum spacing, to stop the future cracking of the internal plastered corners.</p>

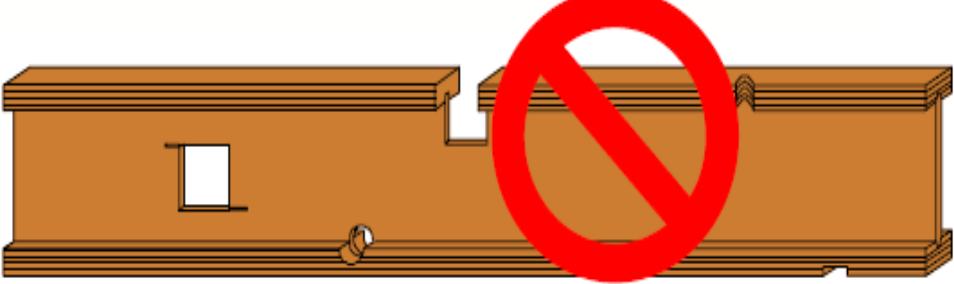
<p>The SmartJoists installation instructions clearly warns:-</p>

<p>DO NOT CUT OR NOTCH FLANGES DO NOT OVER CUT HOLES IN WEB</p> <p>This SmartJoist will have to be properly rectified under the instruction of their manufacturer who should supply the detail for the required rectification work.</p>

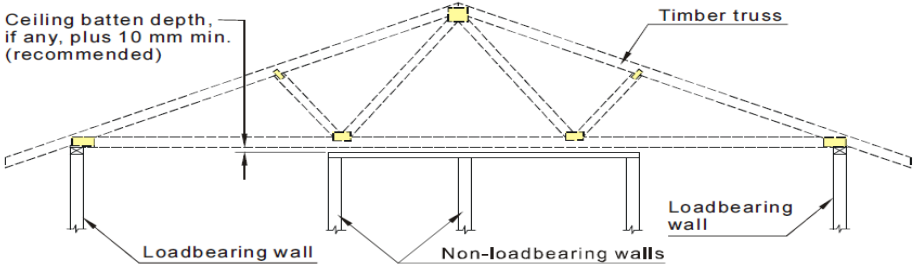
<p>The relevant Australian Standards A.S 1684 Residential Timber-Framed Construction, states in section 6.2.5.2 Internal Walls – Trussed Roofs, that '<i>Non Load-bearing walls shall be kept a <u>minimum of 10mm</u> below the underside of the bottom chord, or ceiling battens when used</i>'. While A.S. 4440 Installation of Nail-plated Timber Roof Trusses, state in section 2.2.2 Non Load-bearing Walls, that '<i>Non load-bearing walls, as designated, shall not carry any truss loading and shall not be packed to touch the underside of trusses (see Figure 2.1)</i>'.</p>

<p>FIGURE 2.1 LOADBEARING AND NON-LOADBEARING WALLS</p> <p>A.S. 4440 Installation of Nail-plated Timber Roof Trusses, also state in Appendix B2 Camber, that '<i>Trusses are built with camber to allow for the initial deflection at the take up of load and some creep (i.e. long-term deflection) as the timber settles. Thus, packing to the underside of a truss over a non load-bearing wall may stop these deflections and in turn support the truss in an incorrect position</i>'.</p> <p>This blocking must be removed and the ceiling lines straightened using one of the other available methods.</p>
