New Home Inspections

PRE-POUR SLAB INSPECTION REPORT AND DEFECTS LIST

Address of Subject Property:
Lot 555 Sample Ave, Sampleville

Date of Inspection – Tuesday 1st April 2014

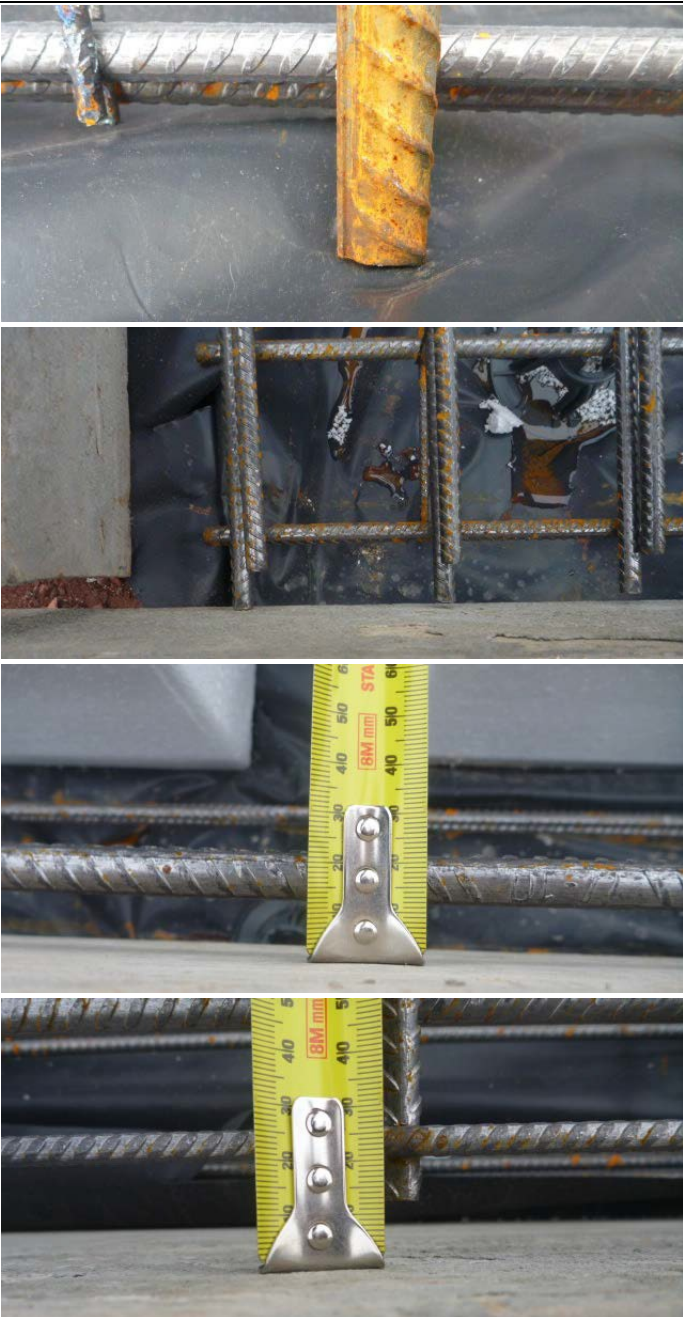
<p data-bbox="413 1435 1528 1602">It is a requirement of Part 3.2.3.2 Steel Reinforcement of the BCA that <i>'Footings and slab-on-ground must have concrete cover between the outermost edge of the reinforcement (including ligatures, tie wire etc.) and the surface of the concrete of not less than 40mm to external exposure.'</i> The requirement is also repeated on Drawing S1 of the approved engineers design.</p> <p data-bbox="413 1625 1528 1701">All of the reinforcement will need to be rectified and confirmed as having this minimum clearance, prior to any concrete being poured.</p>

5.	<p data-bbox="413 1701 1528 1802">The bottom mesh along the right hand side of the Garage, within the deepened edge beam is not being properly supported on chairs or cradles and is currently sitting hard down on the vapour barrier in a number of areas, which it requires a minimum 30mm of clearance from.</p>
